Satellite Imagery and the Libyan Conflict

***A report prepared for the International Commission of
Inquiry on Libya, Office of The High Commissioner for
Human Rights***

February 23, 2012 – Version 2.0

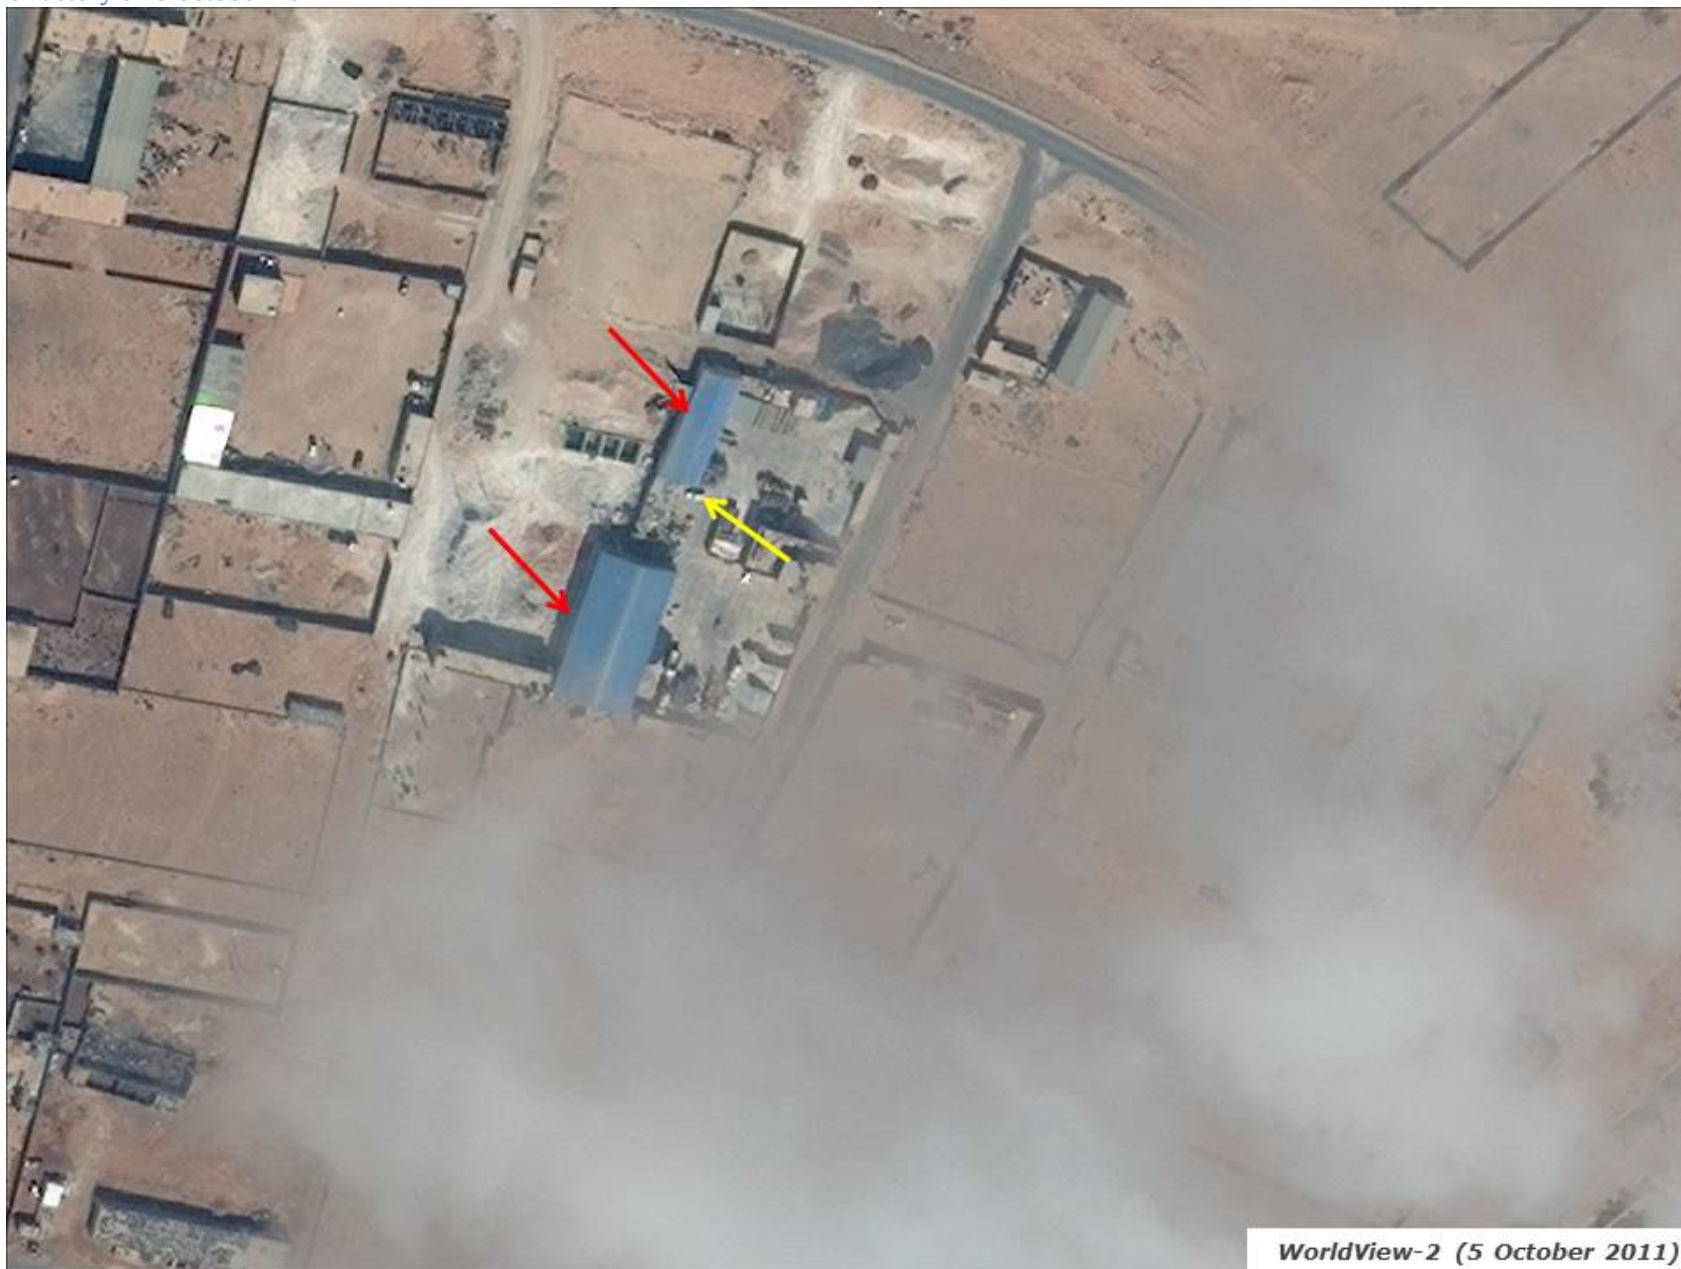
Figure 1. The Tile Factory on 5 October 2011

The two buildings (red arrows) of the Tile Factory on 5 October 2011. Very little vehicle activity was visible at this location across the multiple image dates. Though partially obscured by clouds, 3-4 light trucks are visible in the area with one in the factory yard (yellow arrow).

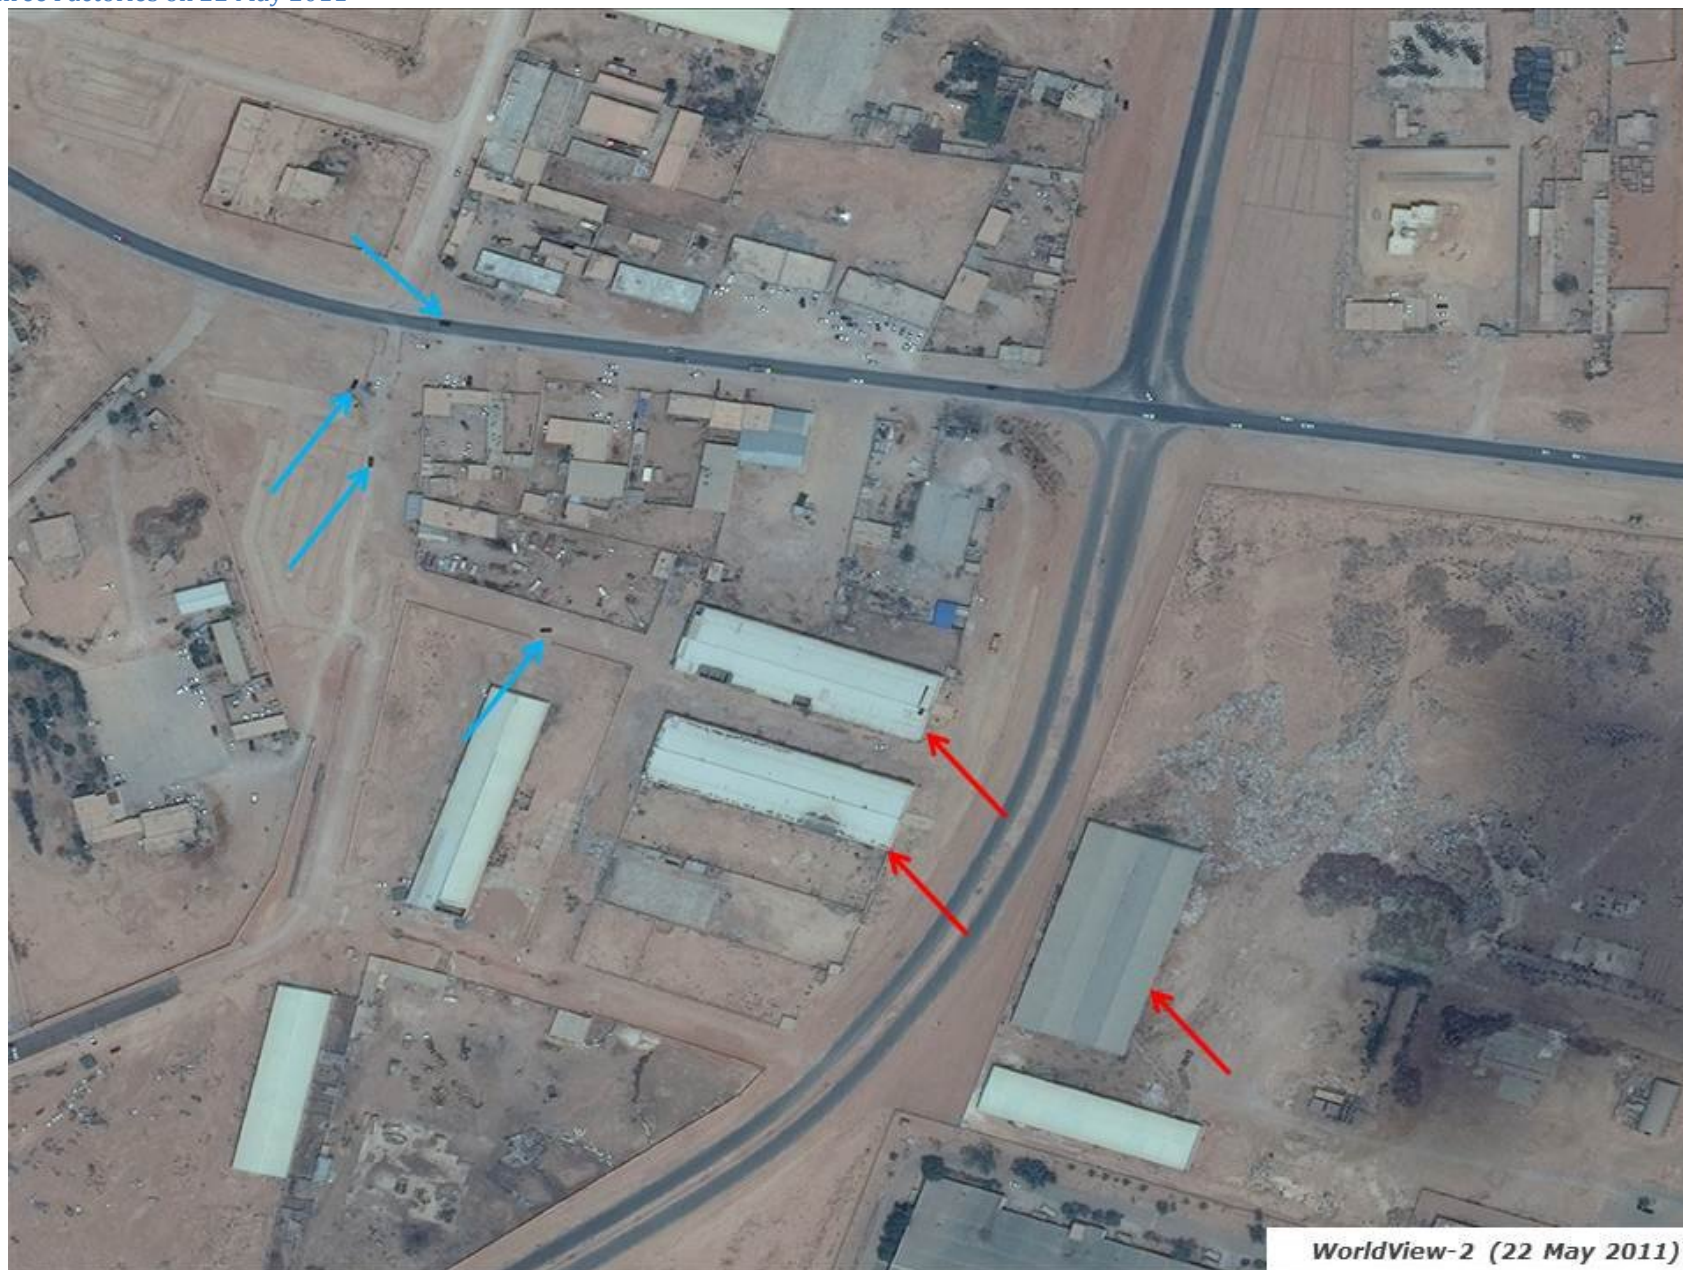
Figure 3. The Three Factories on 22 May 2011

The Three Factories (red arrows) on 22 May 2011. Multiple vehicles are visible in the area, including several possible armored vehicles (blue arrows). Large numbers of vehicles were present across Bani Walid on that date.

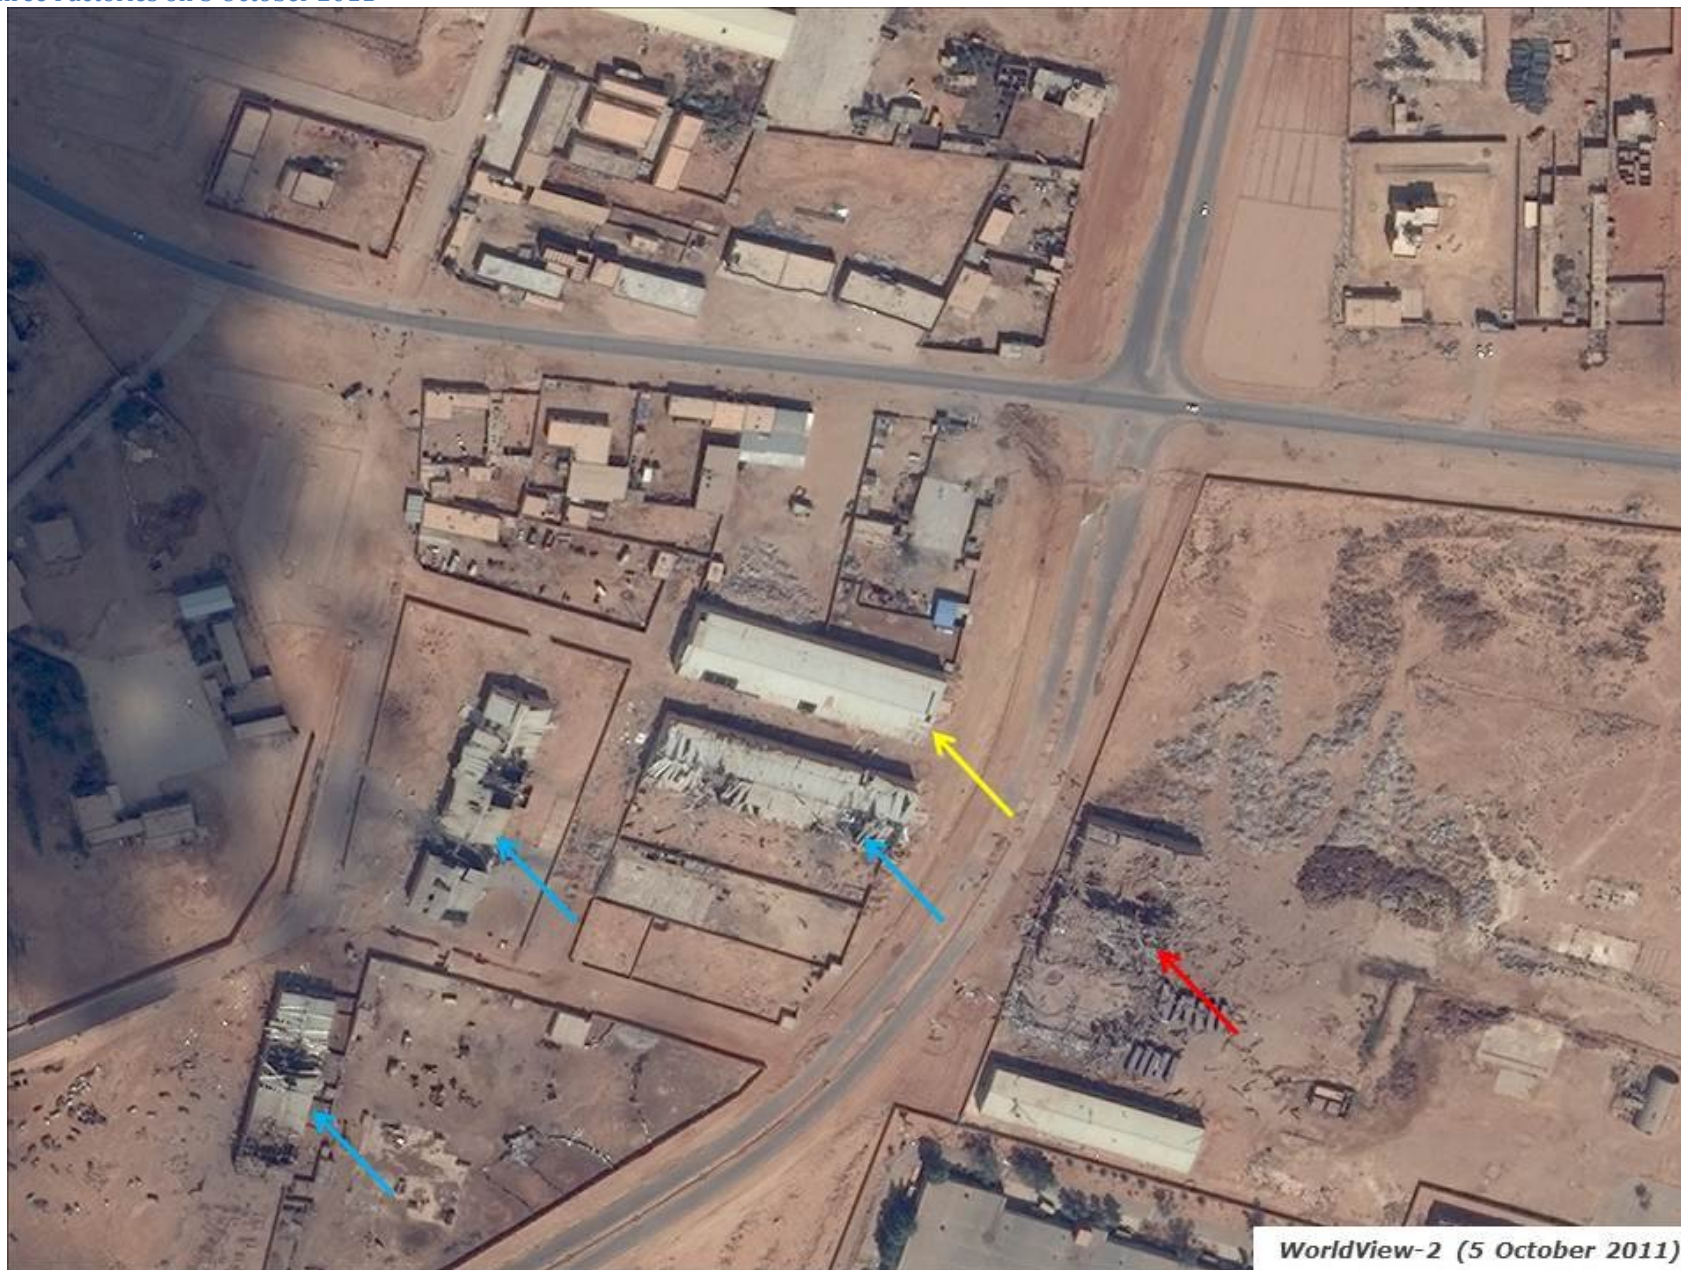
Figure 4. The Three Factories on 5 October 2011

The Three Factories area on 5 October 2011. One building (red arrow) was destroyed between 5 and 13 September. An additional three buildings (blue arrows) were destroyed between 21 September and 5 October. One proximate building remained largely intact (yellow arrow).

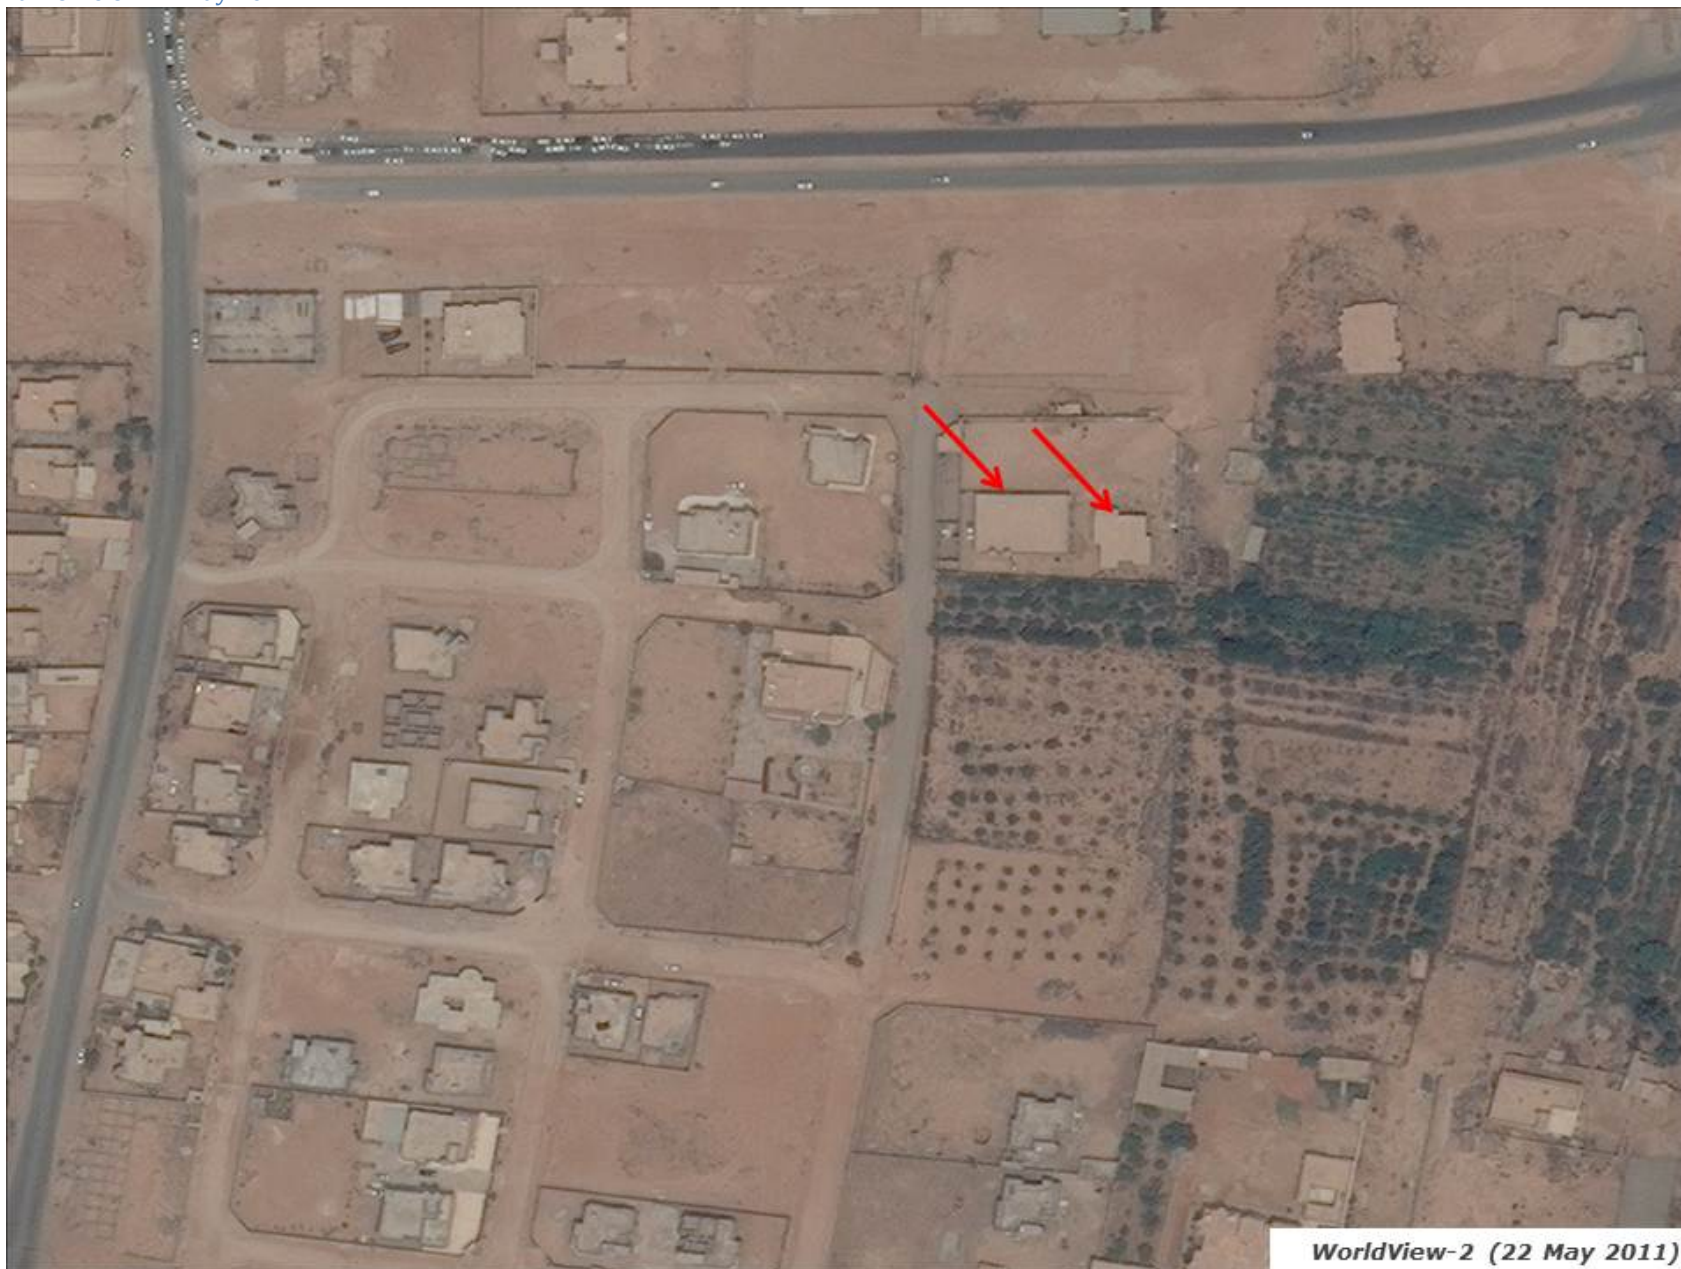
Figure 5. The Jfara Home on 22 May 2011

The buildings of the Jfara compound in Bani Walid (red arrows).

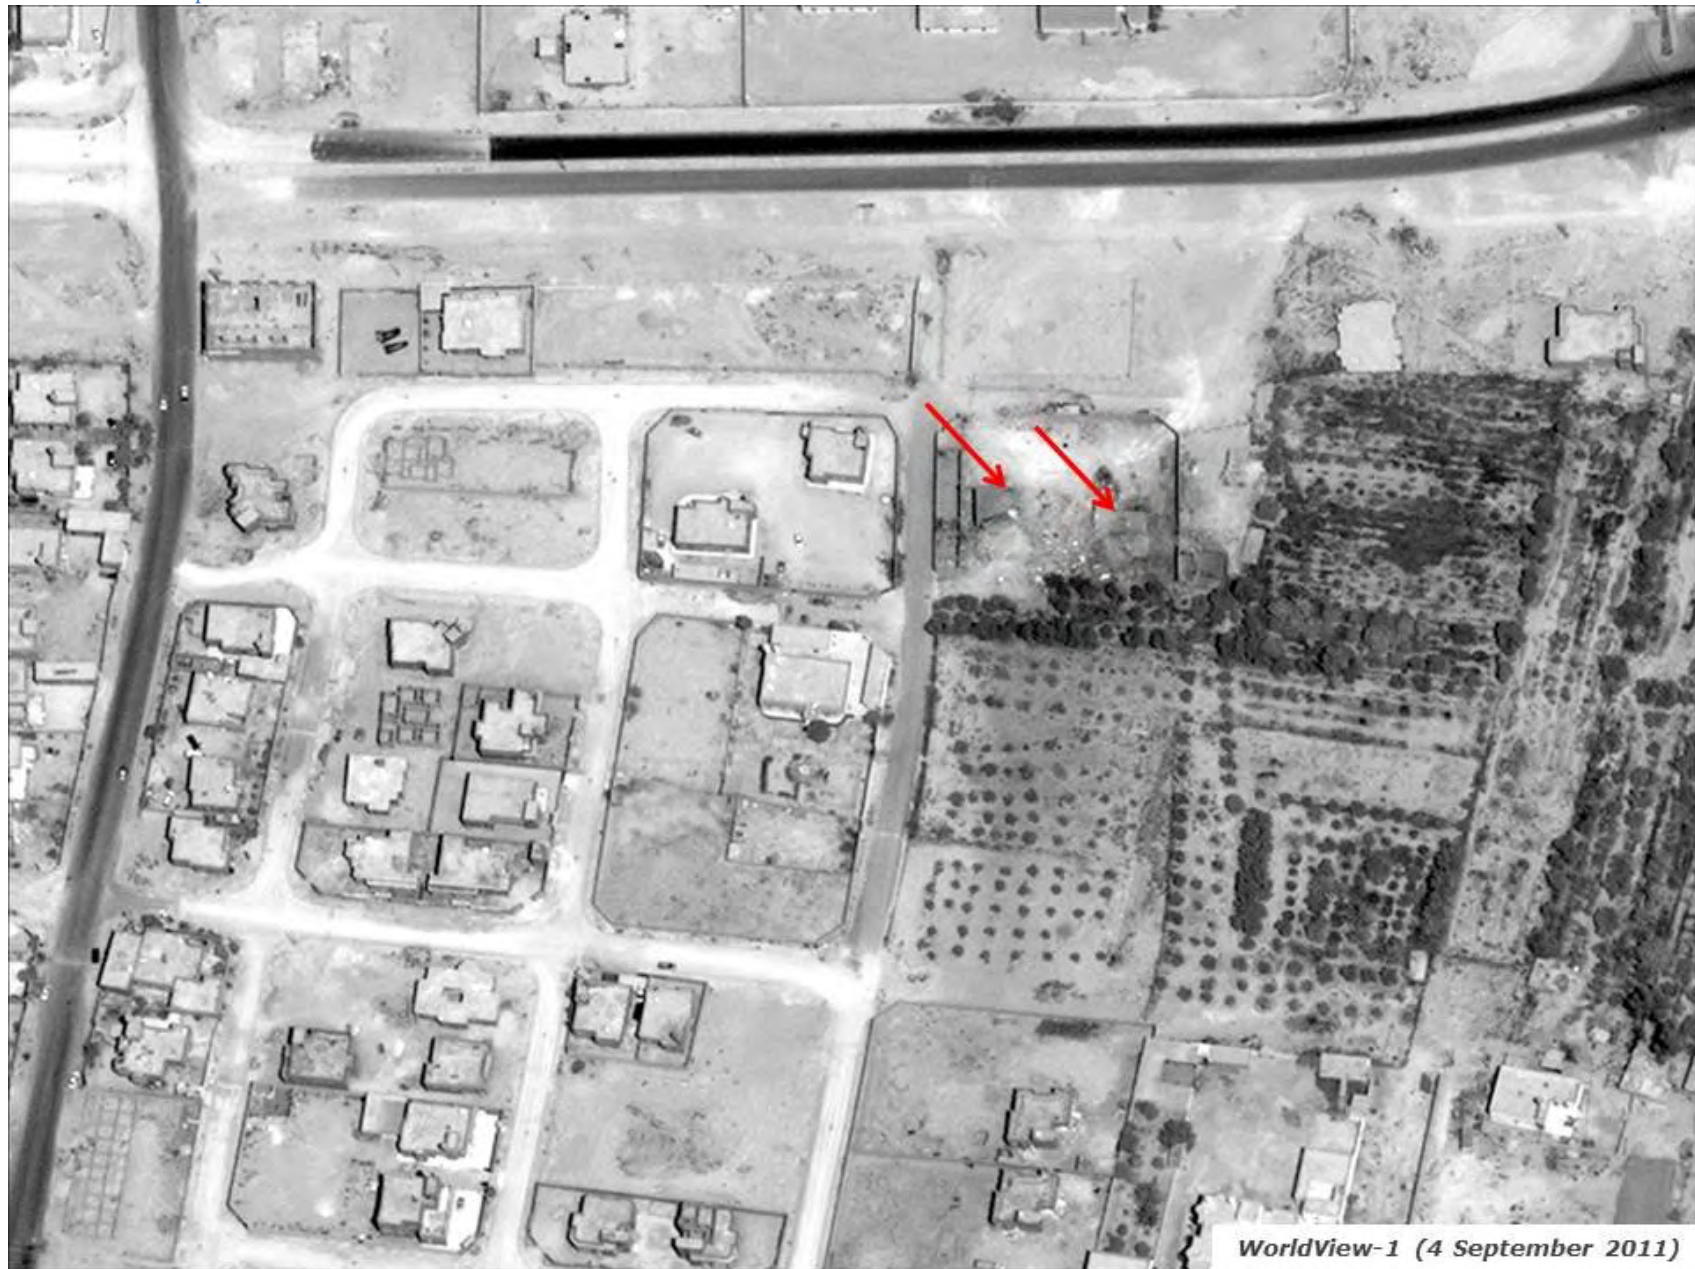
Figure 6. The Jfara Home on 4 September 2011

The remains of the buildings of the Jfara compound (red arrows).

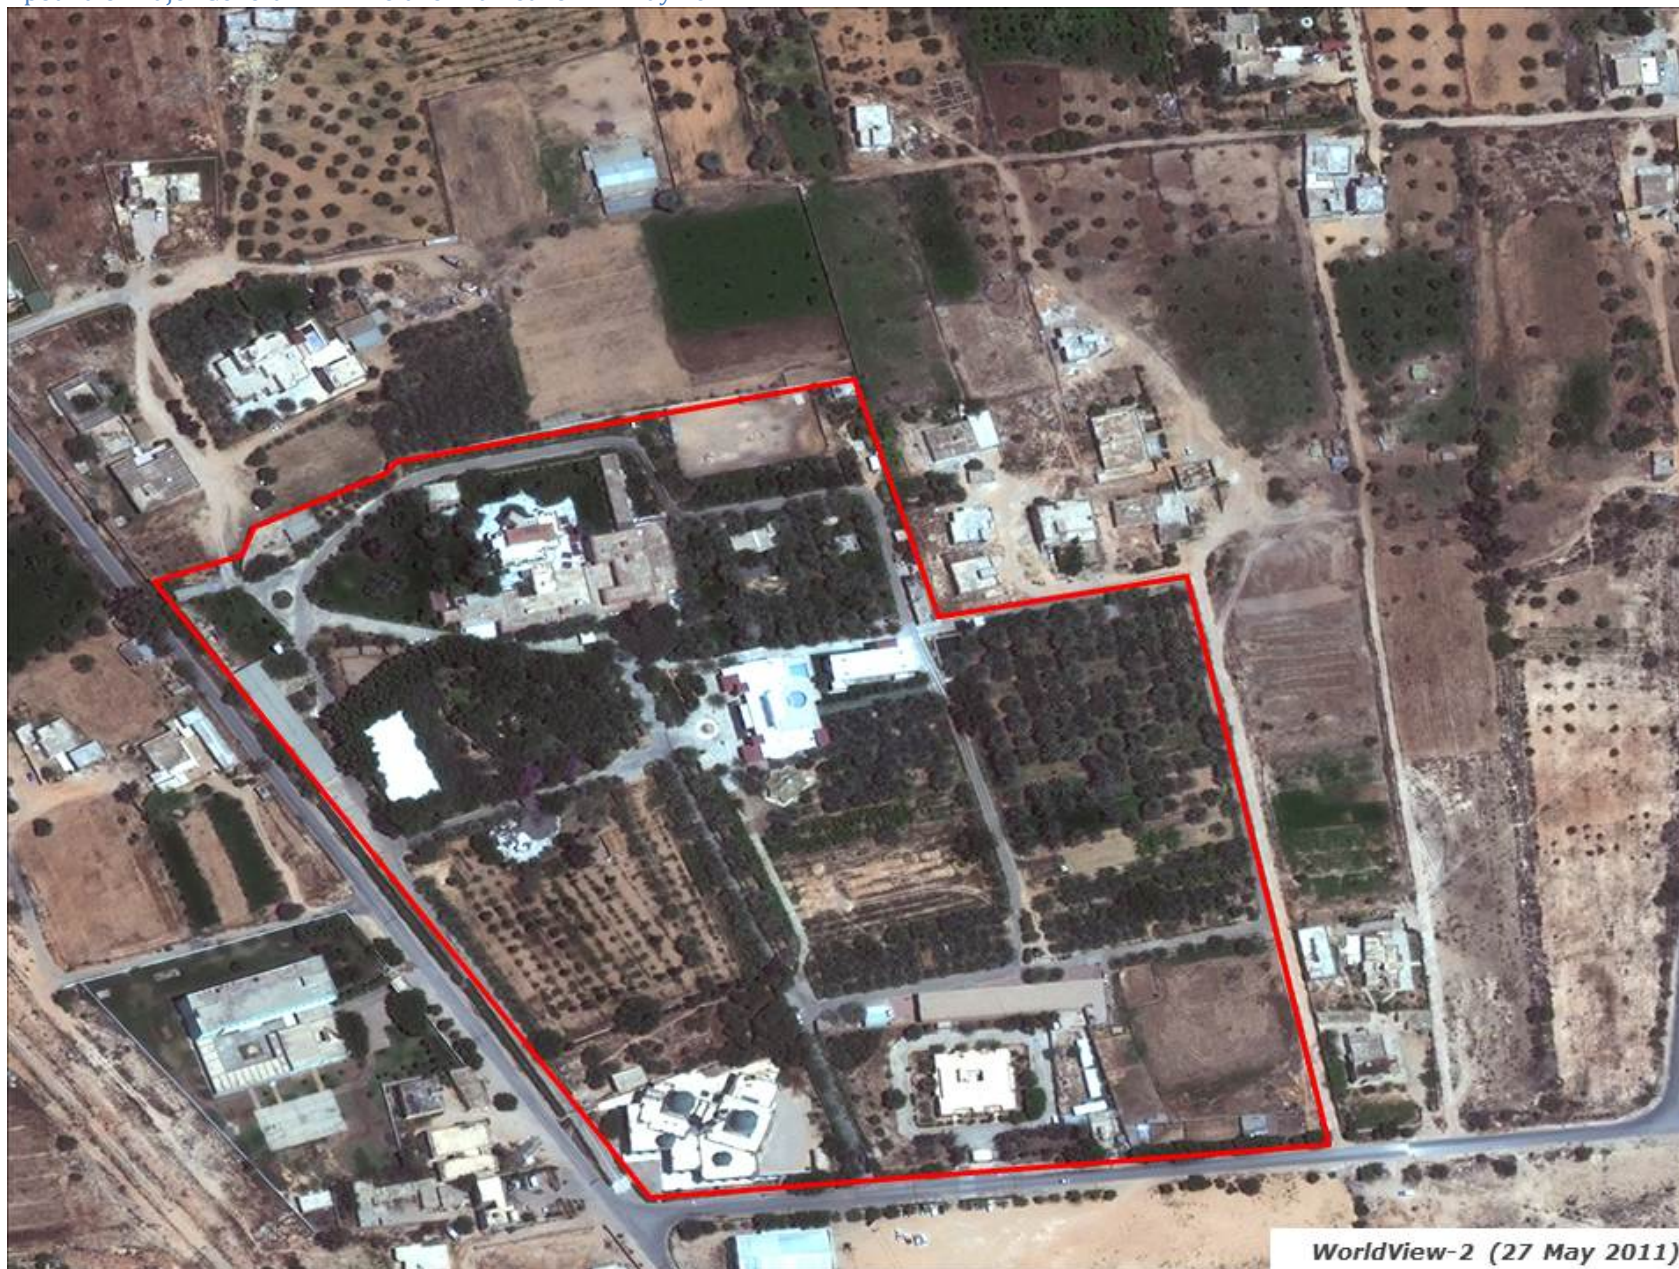
Figure 7. The compound of Major General El-Khweldi el-Hamedy on 27 May 2011

The compound of Major General El-Khweldi el-Hamedy on 27 May 2011 (red outline). A review of the surrounding 25 square kilometres on that date located 4 possible military vehicles about 2.5 kilometres away.

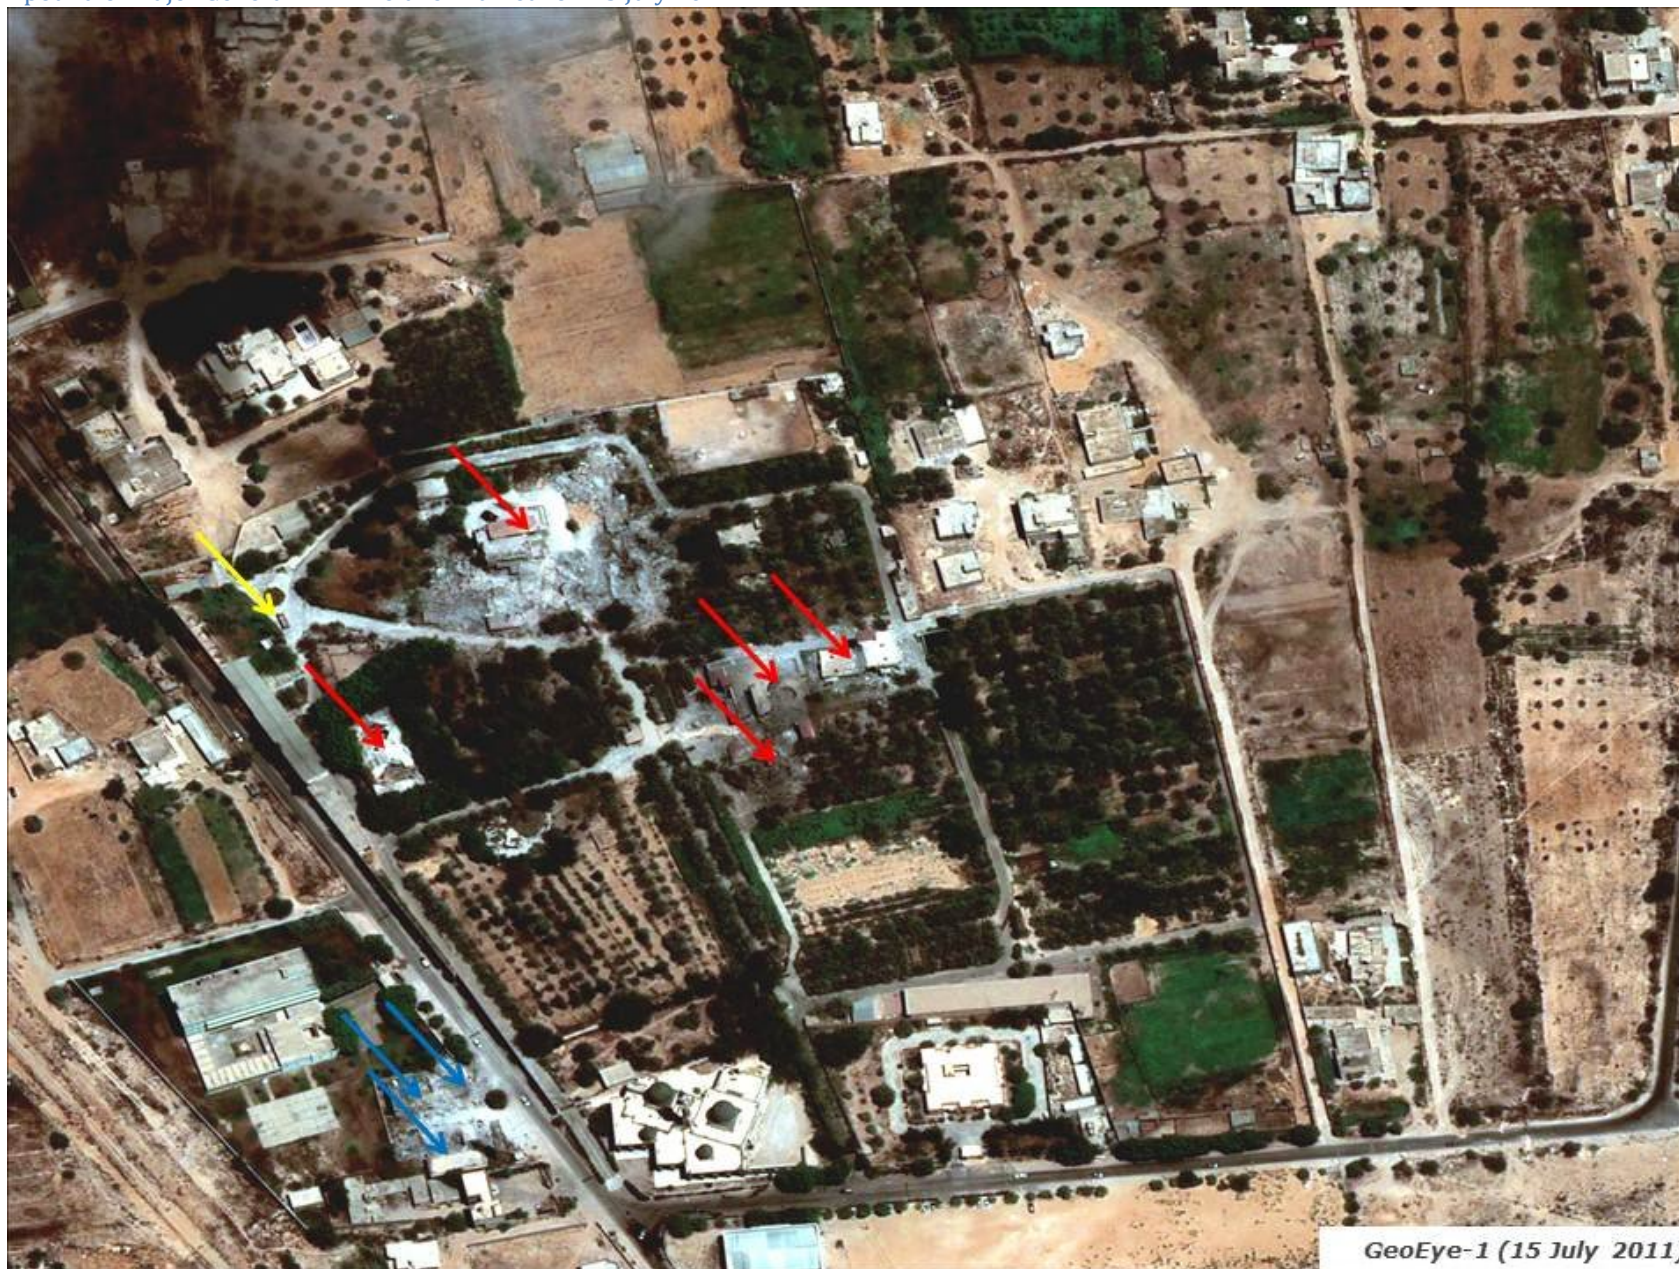
Figure 8. The compound of Major General El-Khweldi el-Hamedi on 15 July 2011

The compound of Major General El-Khweldi el-Hamedi on 15 July 2011. Most buildings have clearly been destroyed or severely damaged (red arrows), and a vehicle with dimensions corresponding to a BMP infantry fighting vehicle is also visible (yellow arrow). Additional buildings across the street with a likely transceiver antenna tower have also been destroyed or severely damaged (blue arrows).

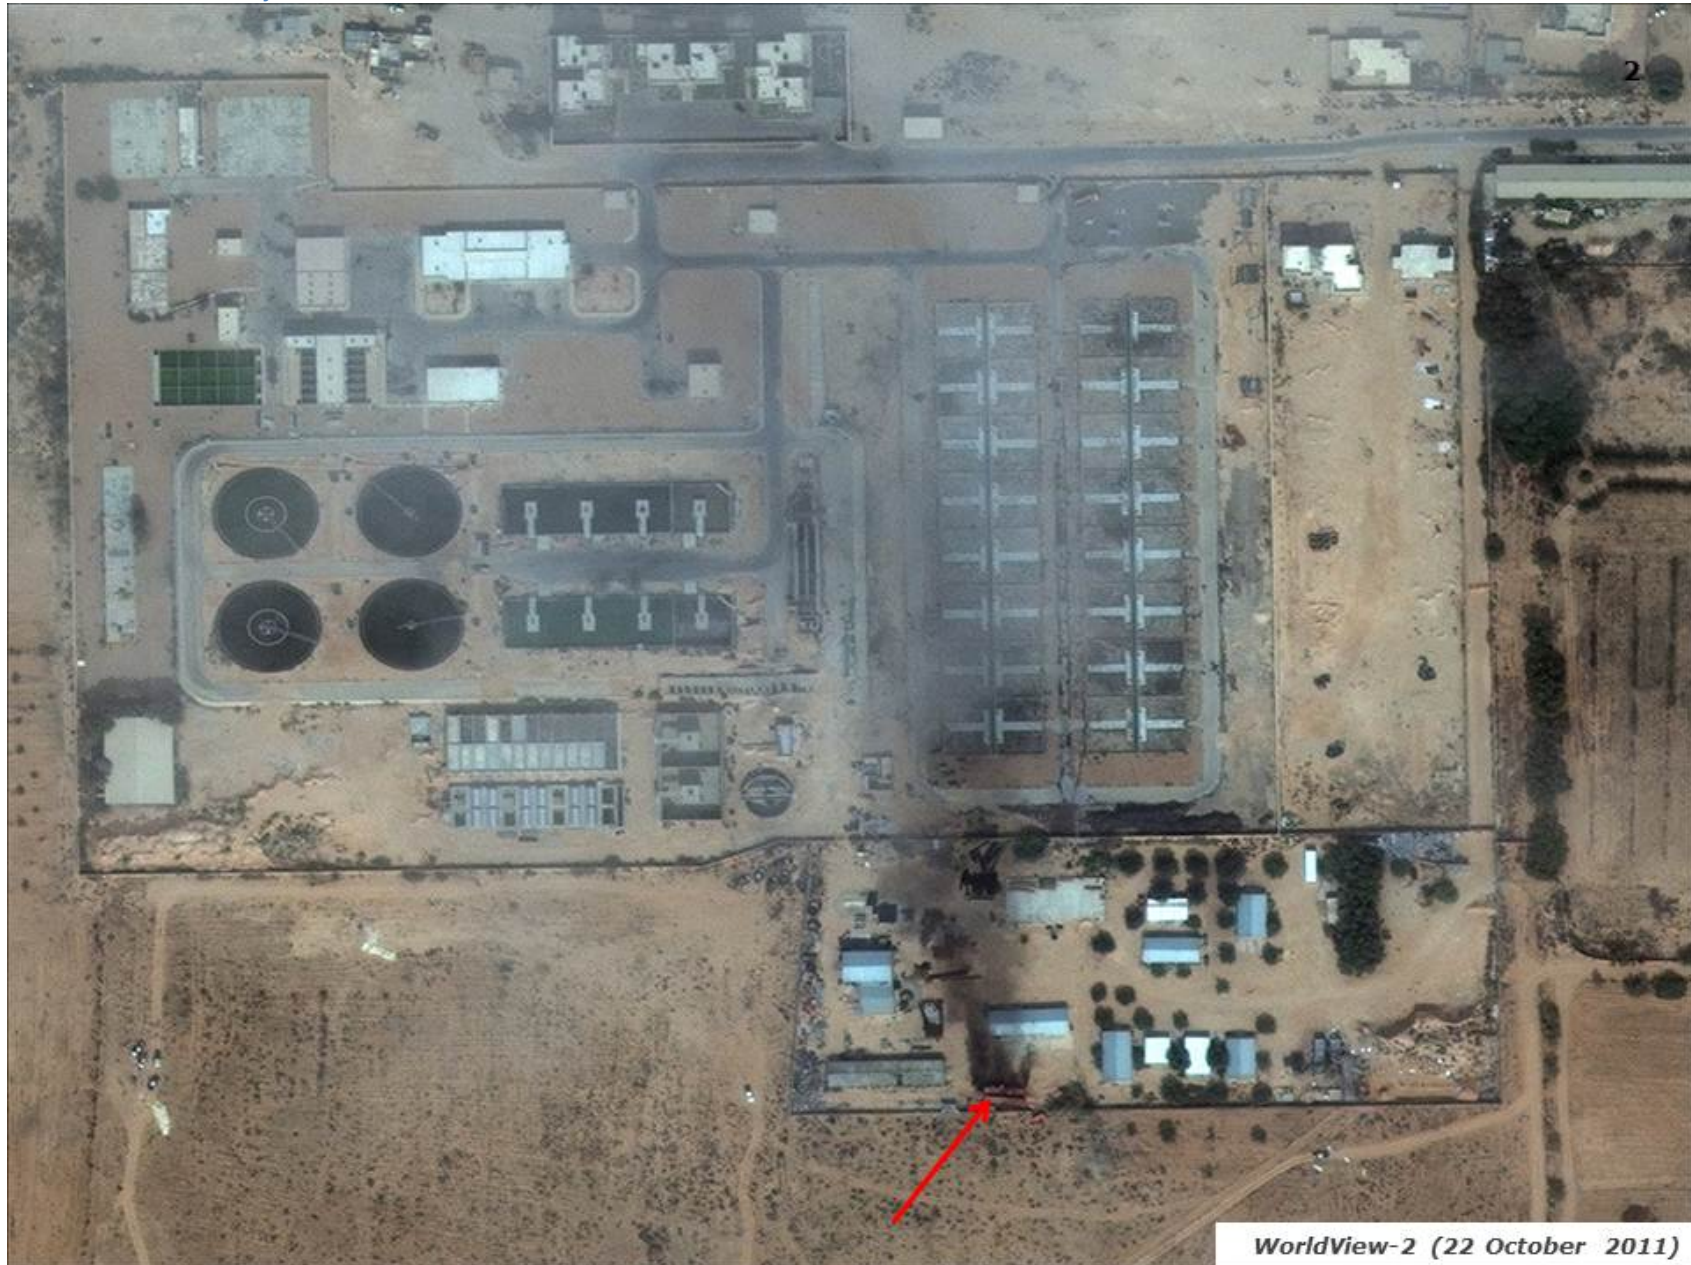
Figure 10. Sirte water treatment facility

A smoke plume (red arrow) from a small fire burning at the water treatment plant near where Gadaffi was captured. Multiple light trucks commonly used in the fighting also visible nearby.

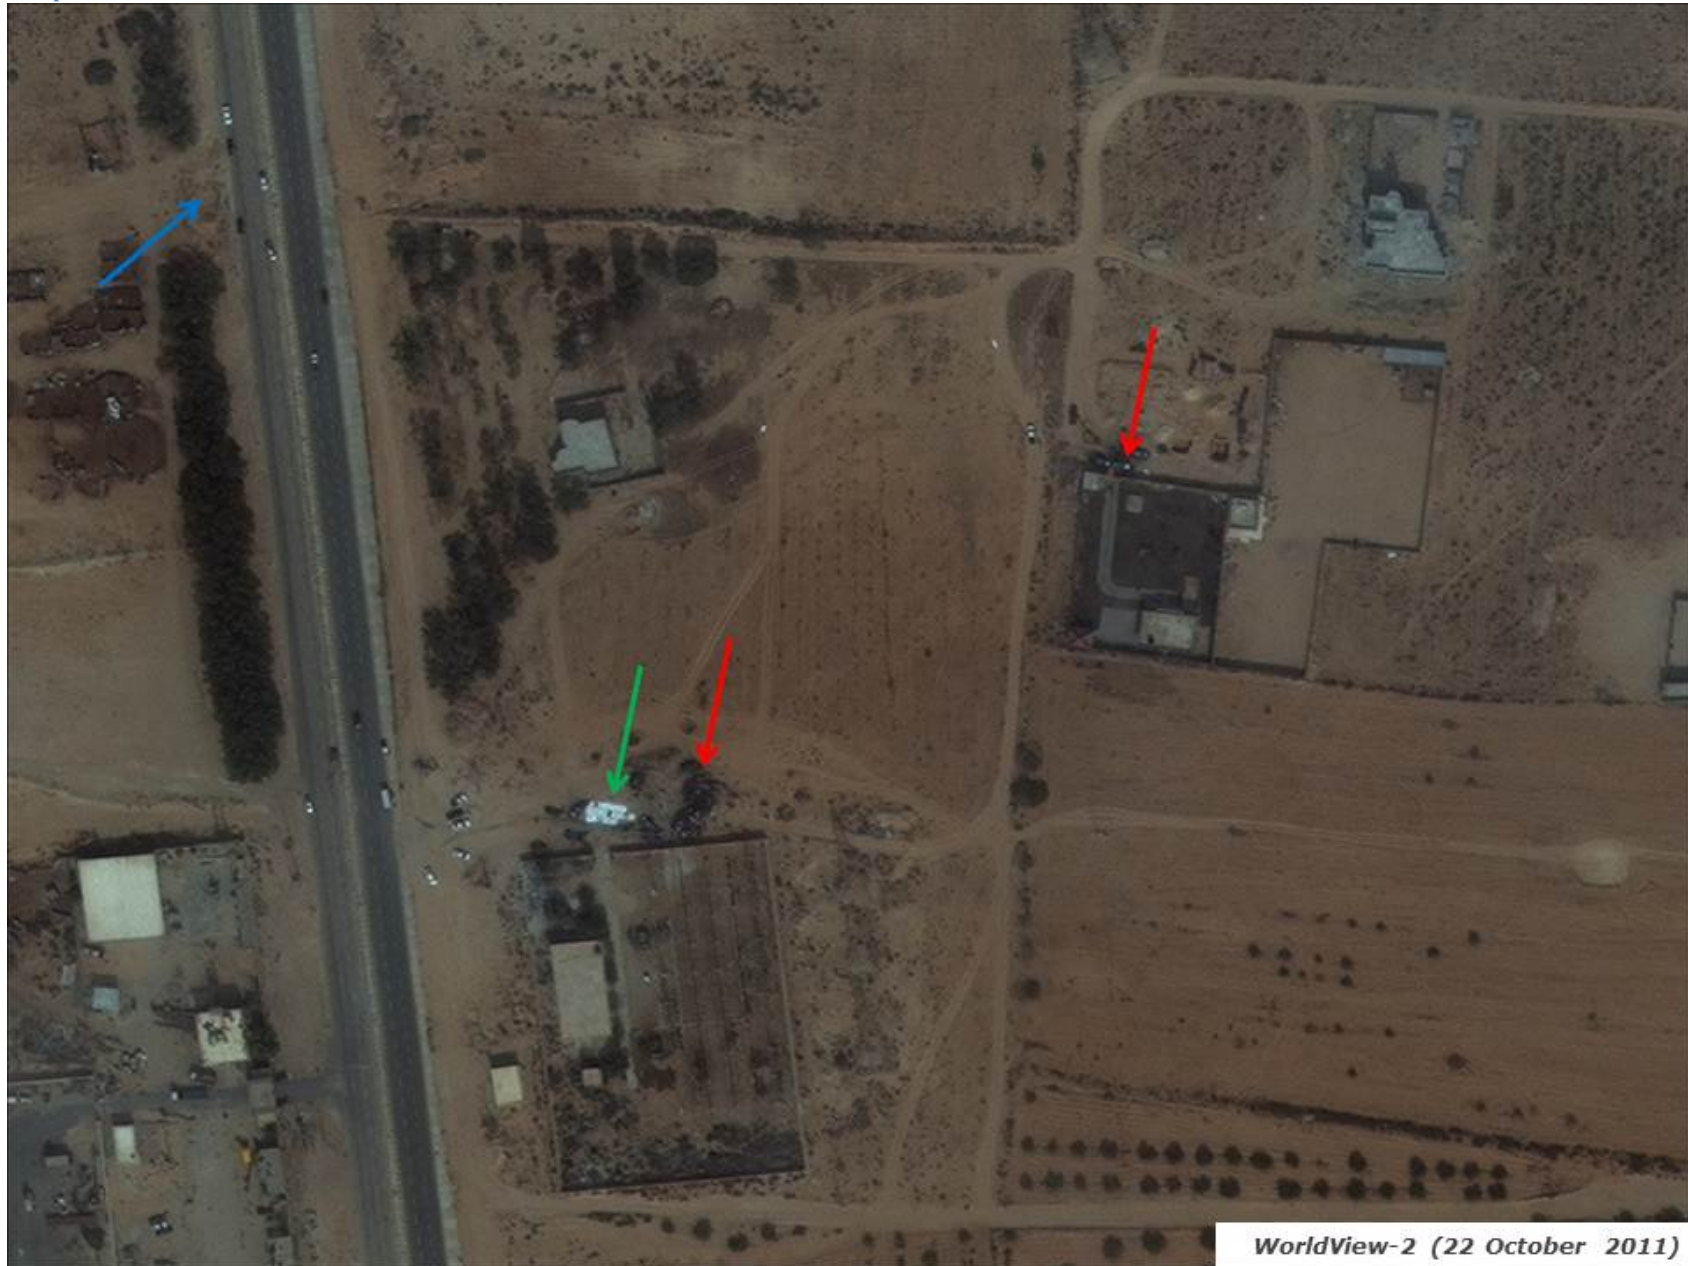
Figure 11. Gadaffi capture area

The area of Moammar Gadhafi's capture. Destroyed light trucks (red arrows) are visible, as are body bags (green arrow). The culvert area where Gadhafi was apprehended is indicated with a blue arrow.

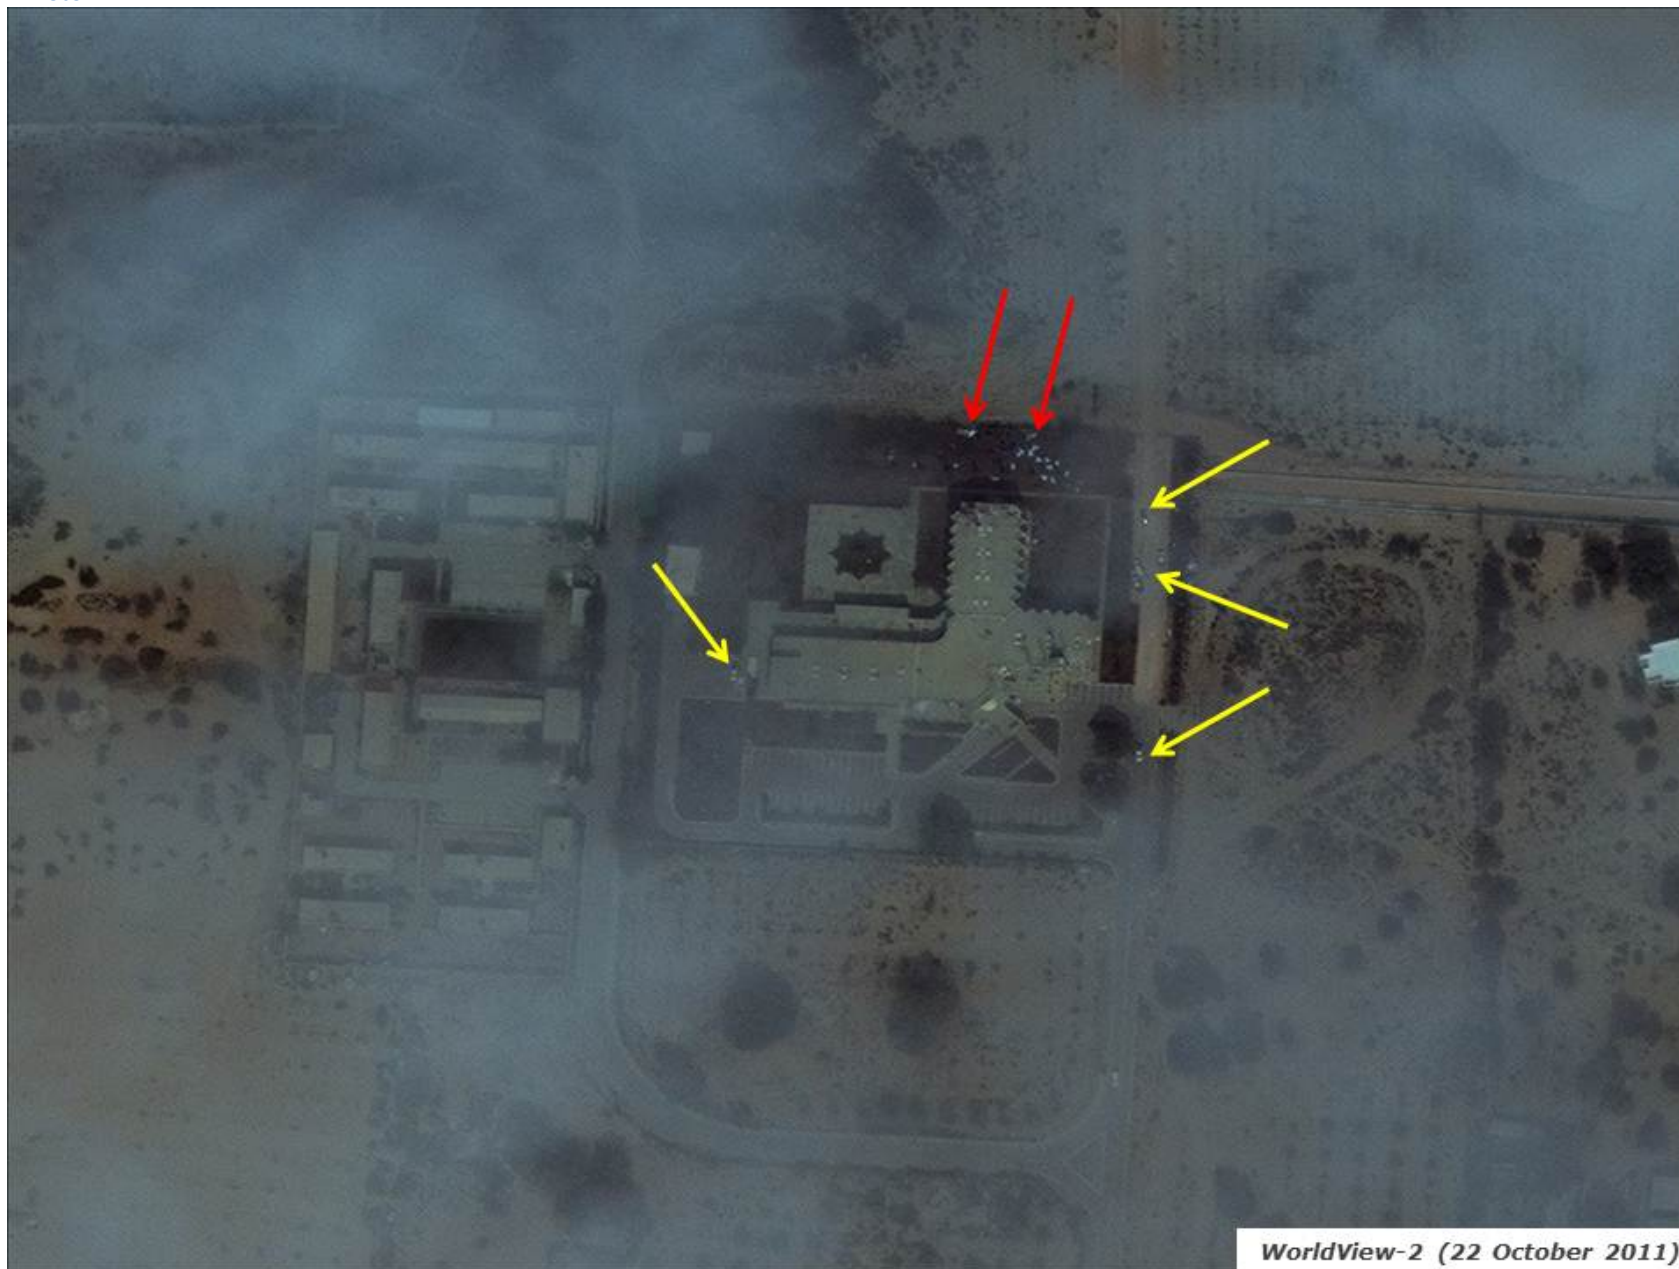
Figure 12. Mahari Hotel

The Mahari Hotel area near Sirte. Twenty-two covered bodies identified by the on the ground photos possibly visible (red arrows), and numerous light trucks are present (yellow arrows). Location showed similar activity the previous day (21 October), though with less vehicles and 13 possible covered bodies.
