Satellite Imagery and the Libyan Conflict

***A report prepared for the International Commission of
Inquiry on Libya, Office of The High Commissioner for
Human Rights***

February 23, 2012 – Version 2.0

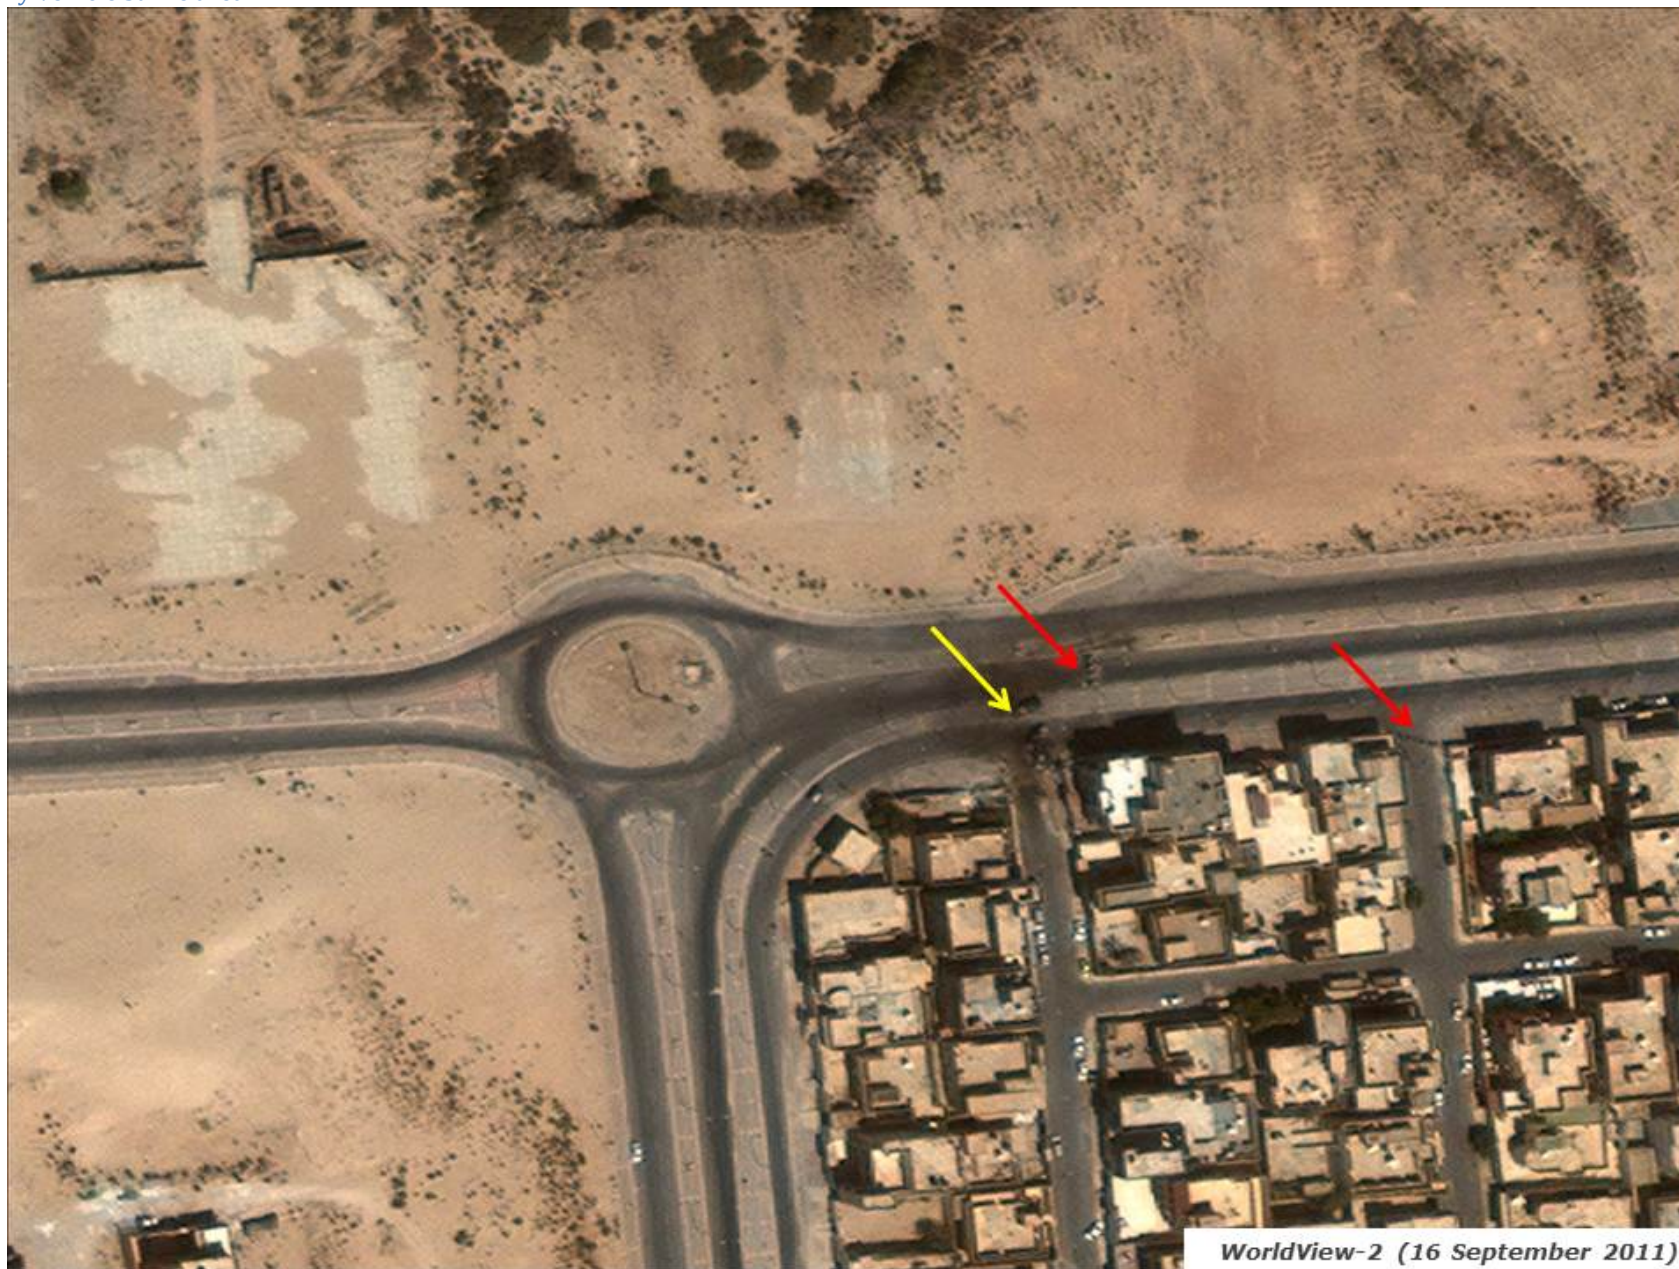
Figure 13. Military vehicle strike area

The area of the 'Military Vehicle Strike'. Roadblocks (red arrows) are visible, as well as the aftermath of the airstrike (yellow arrow), which includes 2 – 3 destroyed vehicles. The roadblock on the primary road was constructed between 3 and 6 September.

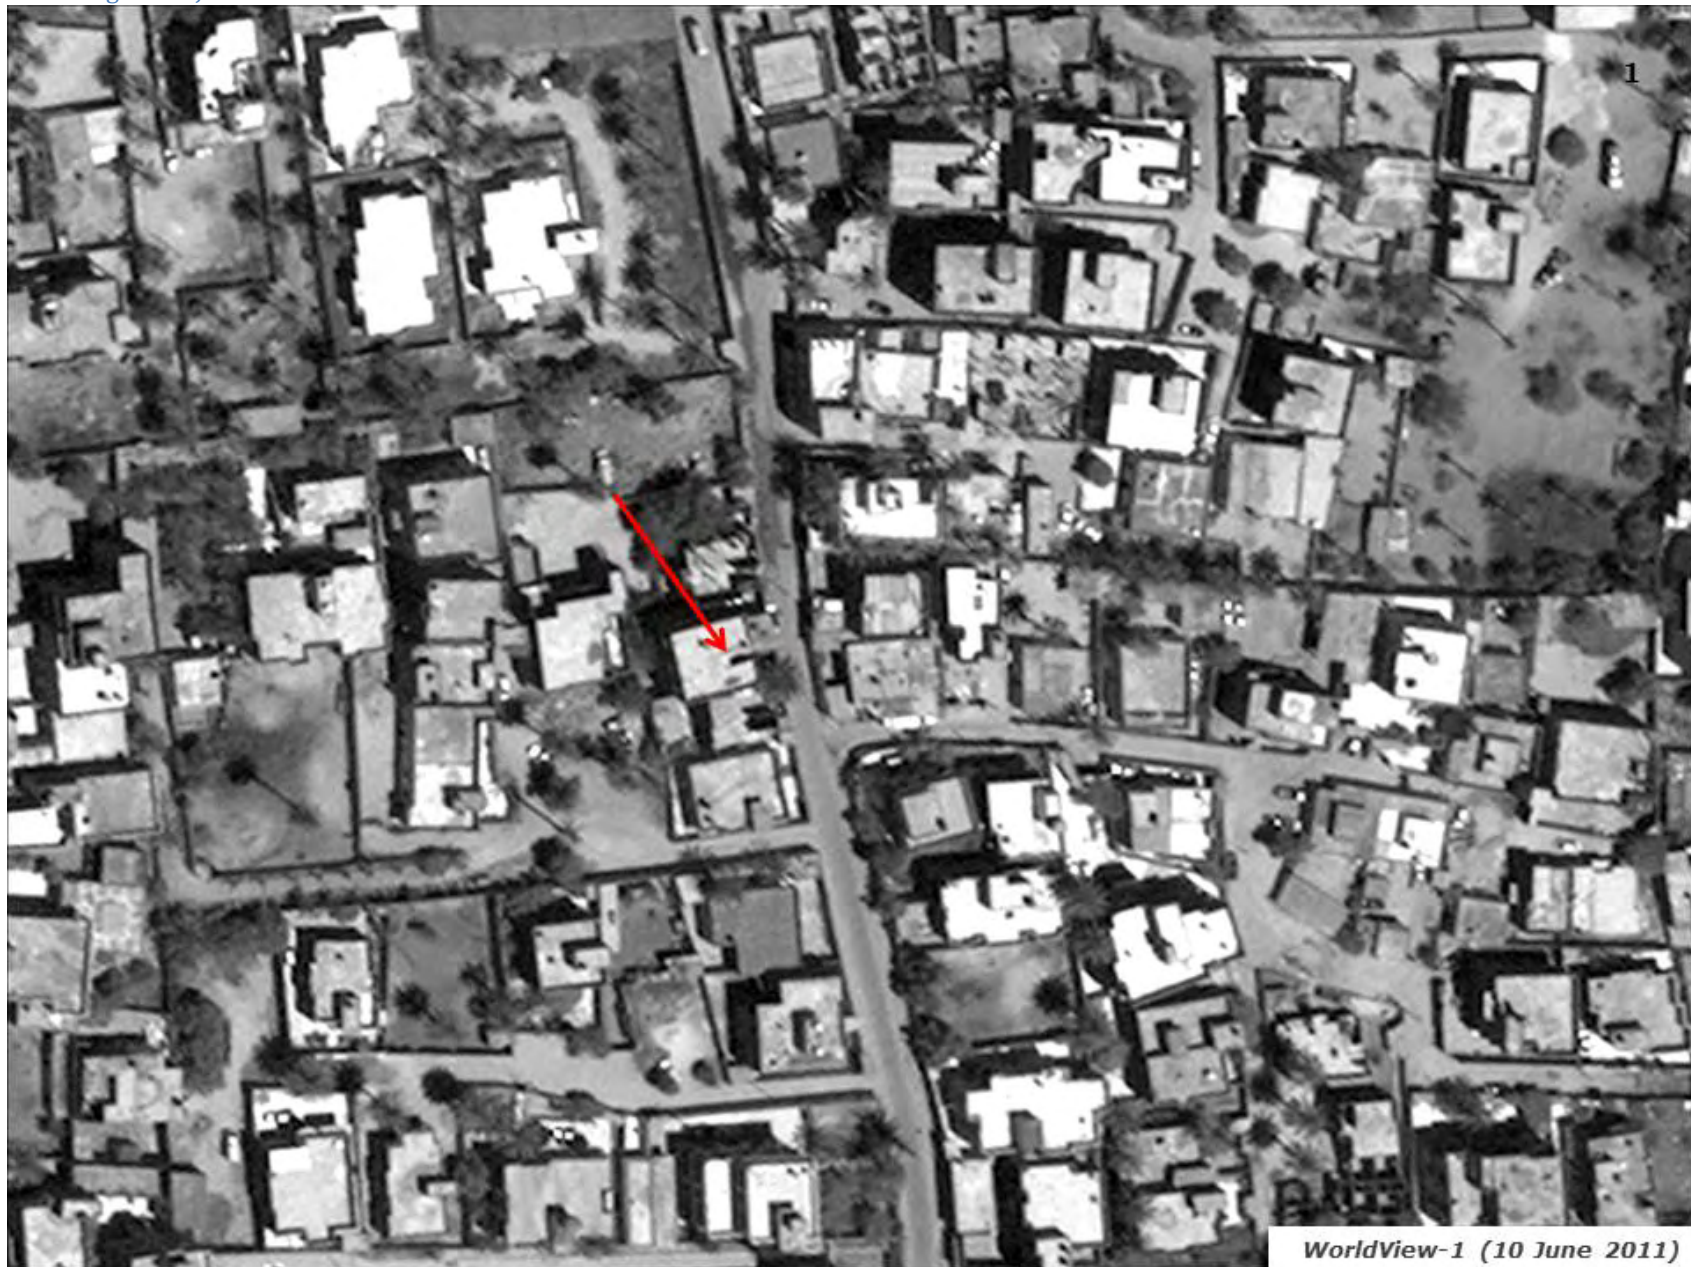
Figure 18. Tripoli building on 10 June 2011

The location in question (see red arrow) on 10 June 2011. Structure is intact, the rooftop is clearly delineated, and a tree on the roadside next to the structure is visible.

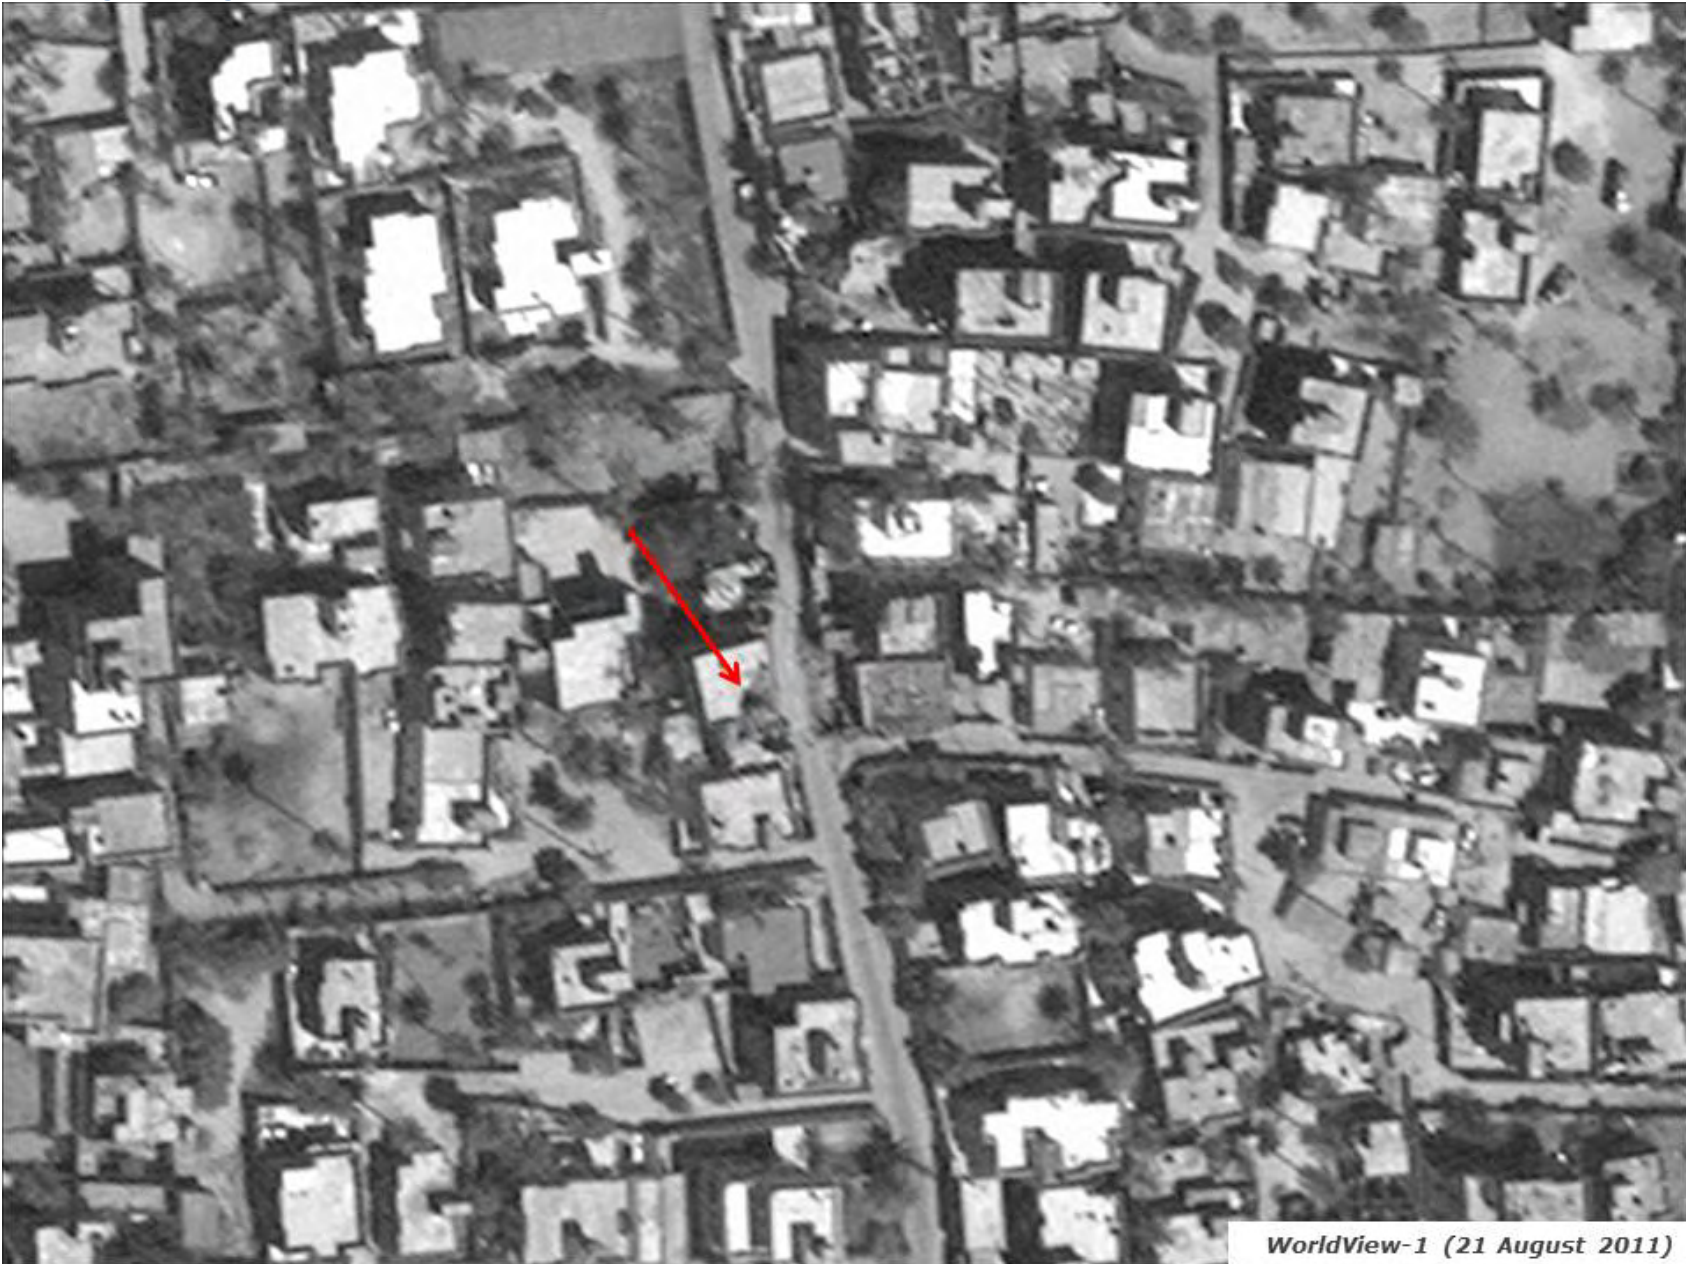
Figure 19. Tripoli building on 21 August 2011

The location in question (see red arrow) on 21 August 2011. Though of poor quality the image clearly shows changes in the roof of the structure, indicating building collapse, and the proximate tree is gone.

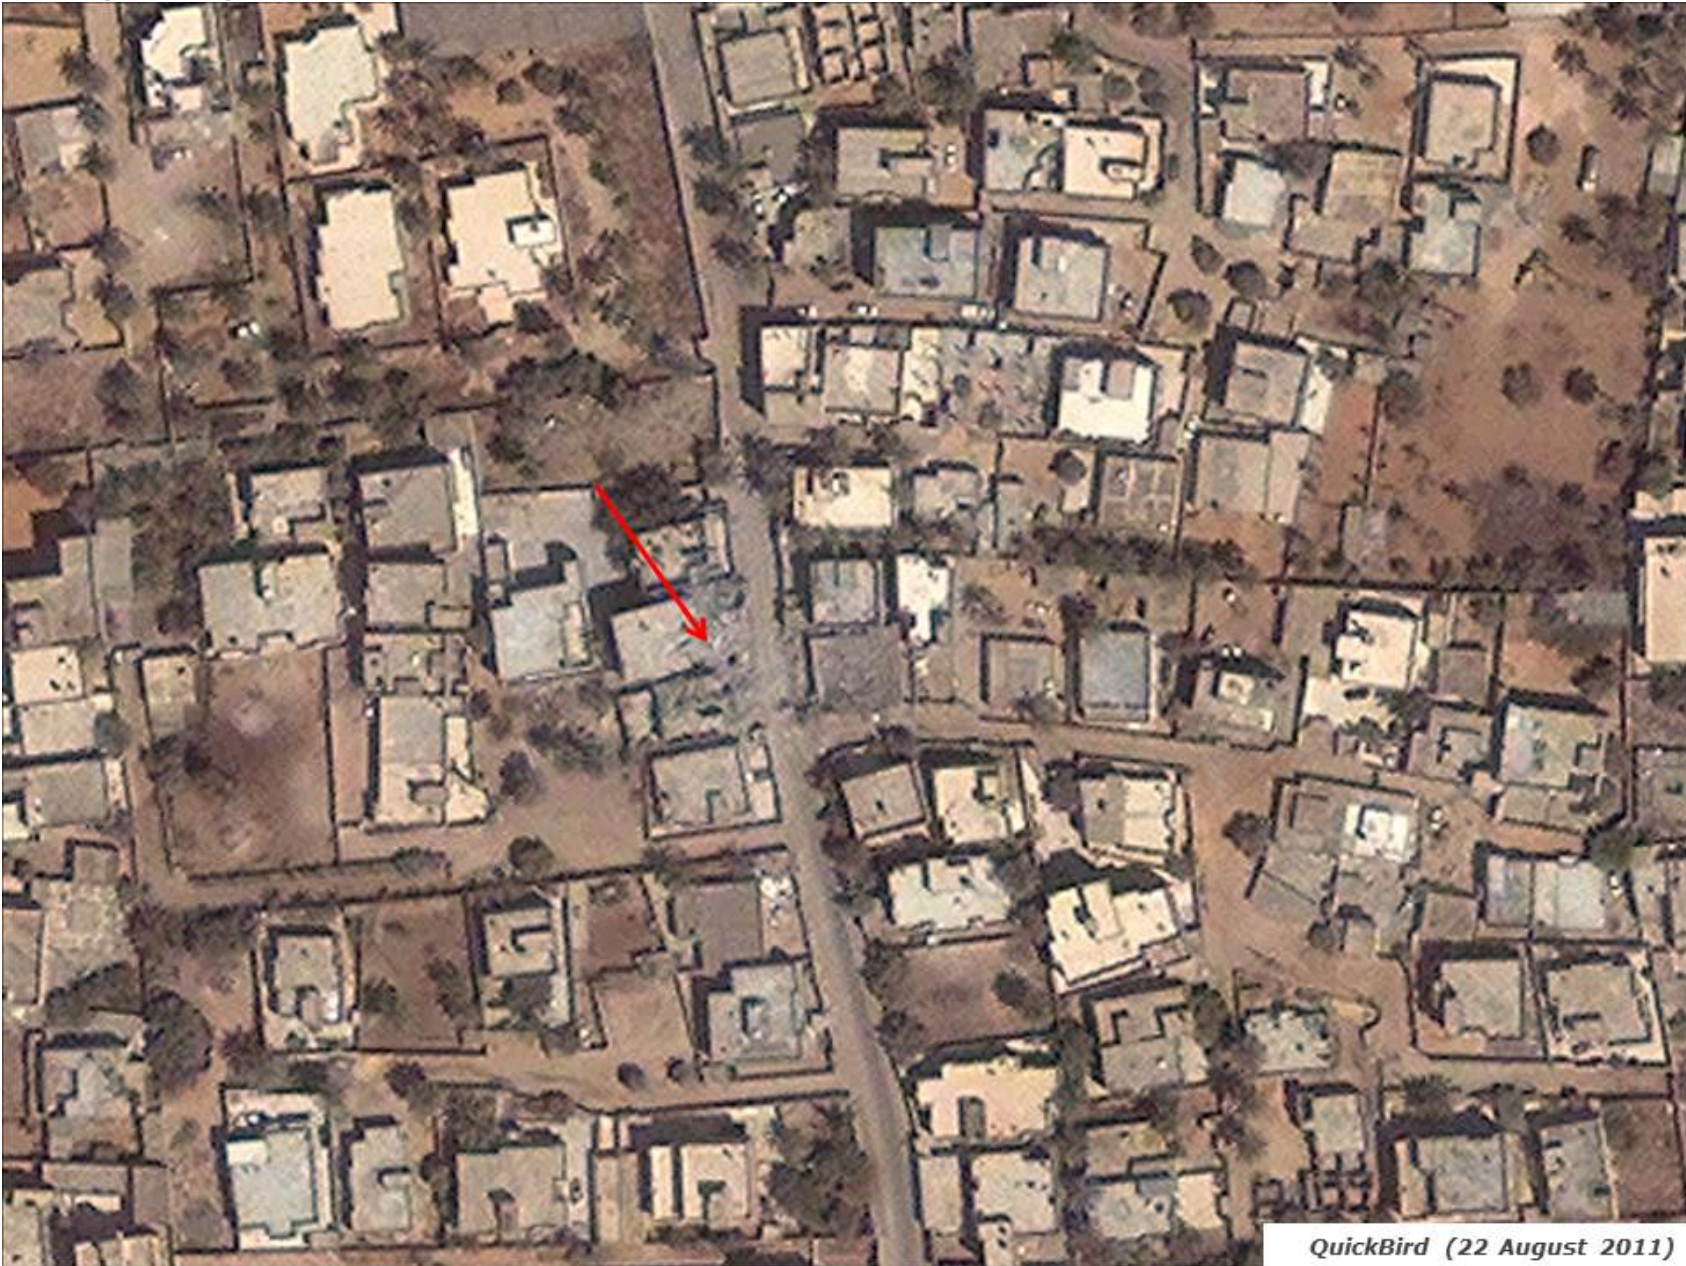
Figure 20. Tripoli building on 22 August 2011

The location in question (see red arrow) on 22 August 2011. The appearance of the roof is markedly different compared with the image from 10 June, and a clearer view of the collapsed portion of the building is apparent.

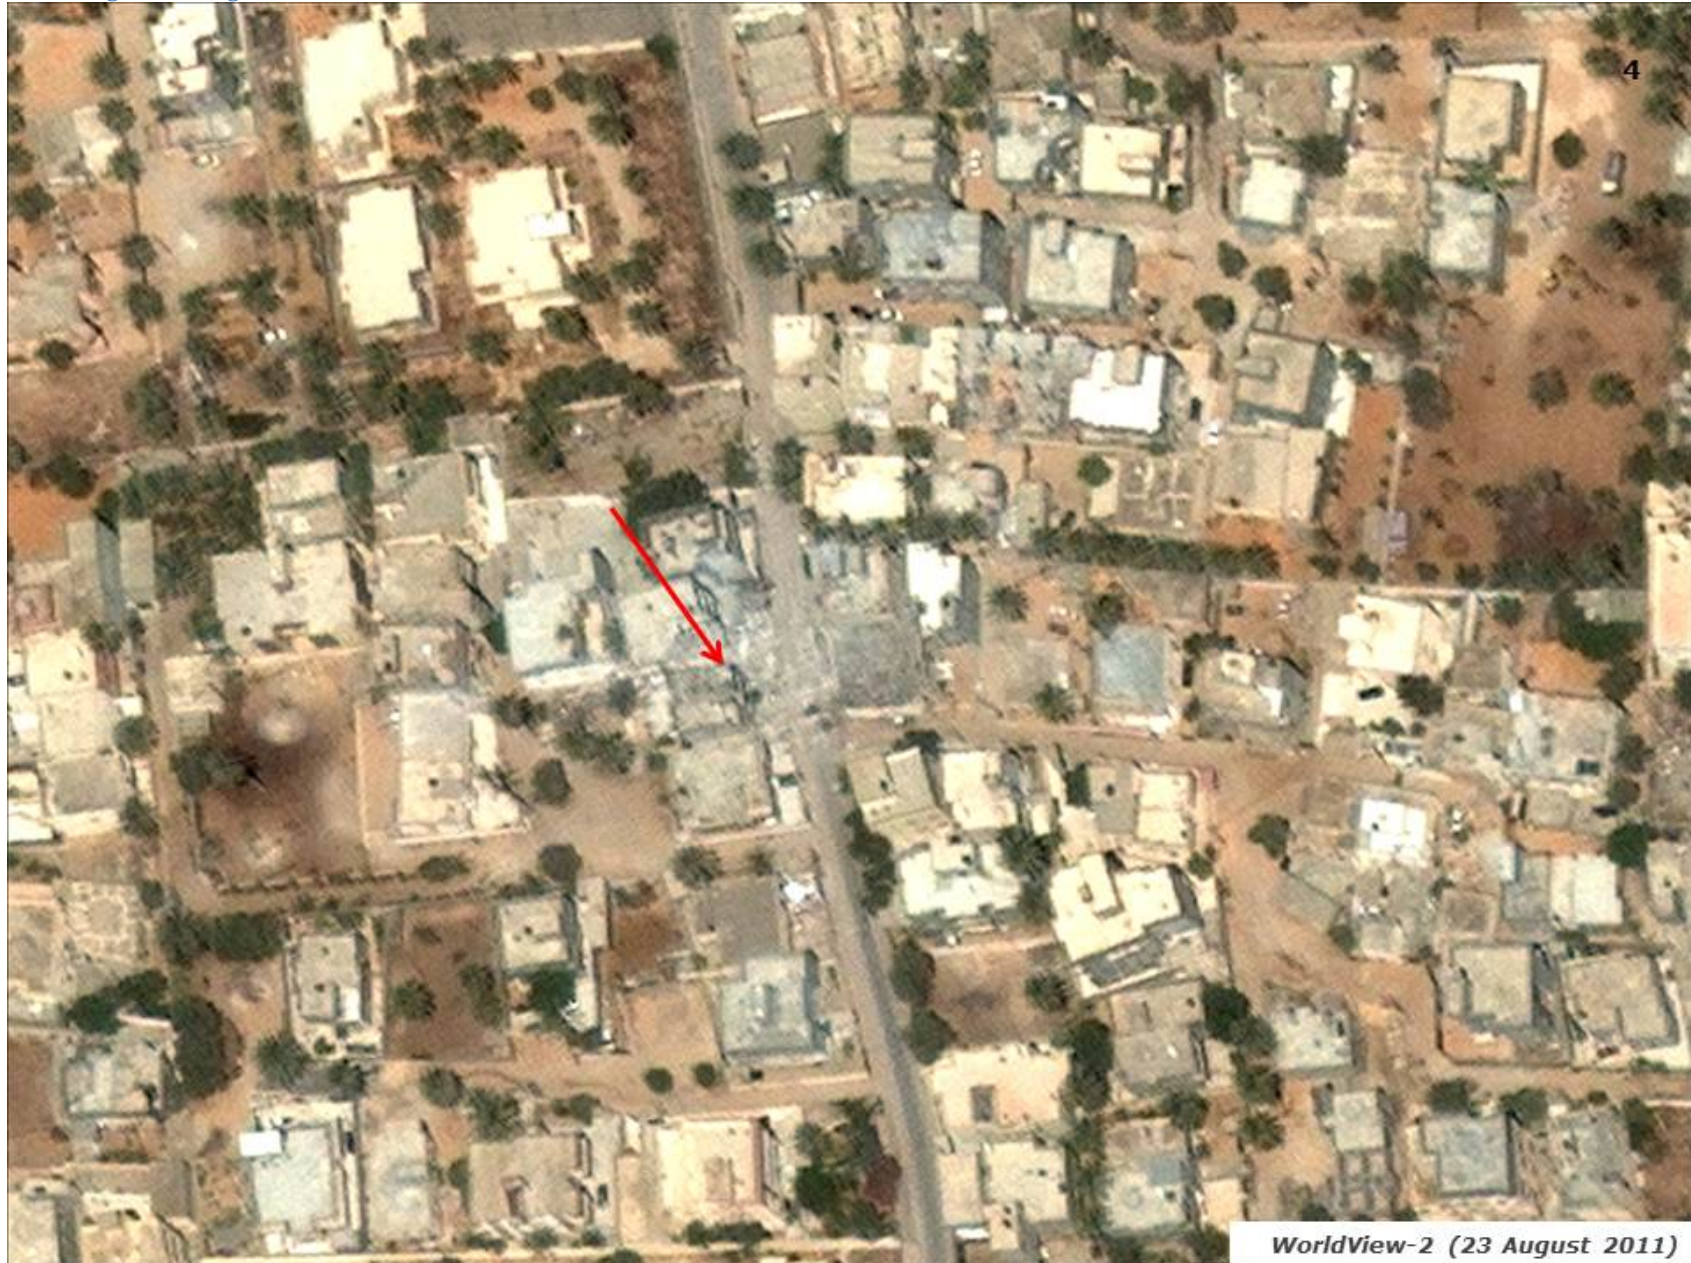
Figure 21. Tripoli building on 23 August 2011

An additional image of the structure (see red arrow) was collected on 23 August 2011. The angle of the image acquisition provides a view of the collapsed front of the building with concrete debris likely accounting for the lighter appearance of the adjacent street.

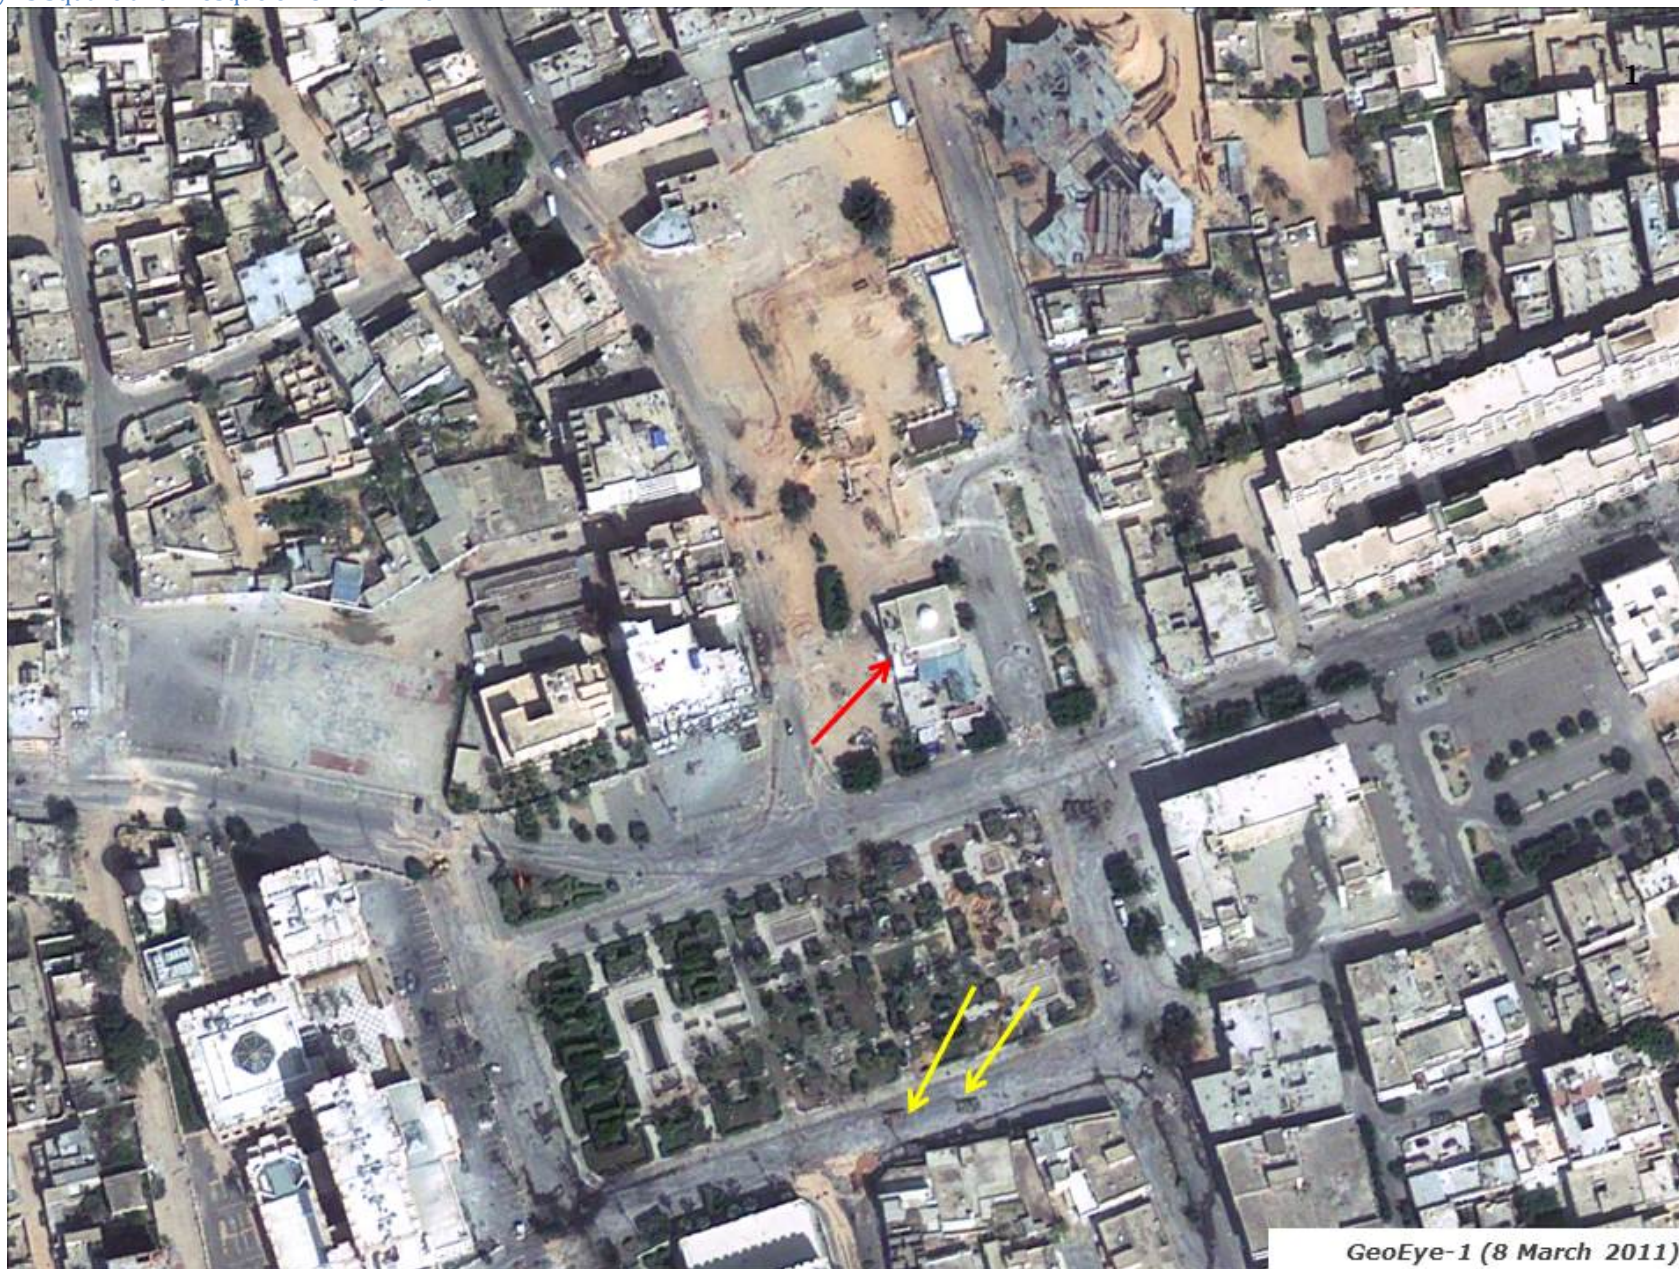
Figure 22. Martyr's Square and mosque on 8 March 2011

The mosque in Martyr's Square in Zawiyah (red arrow) on 8 March 2011 as pro-Gadaffi forces were attacking the city. Two tanks are visible (yellow arrows) with guns pointed across the square.

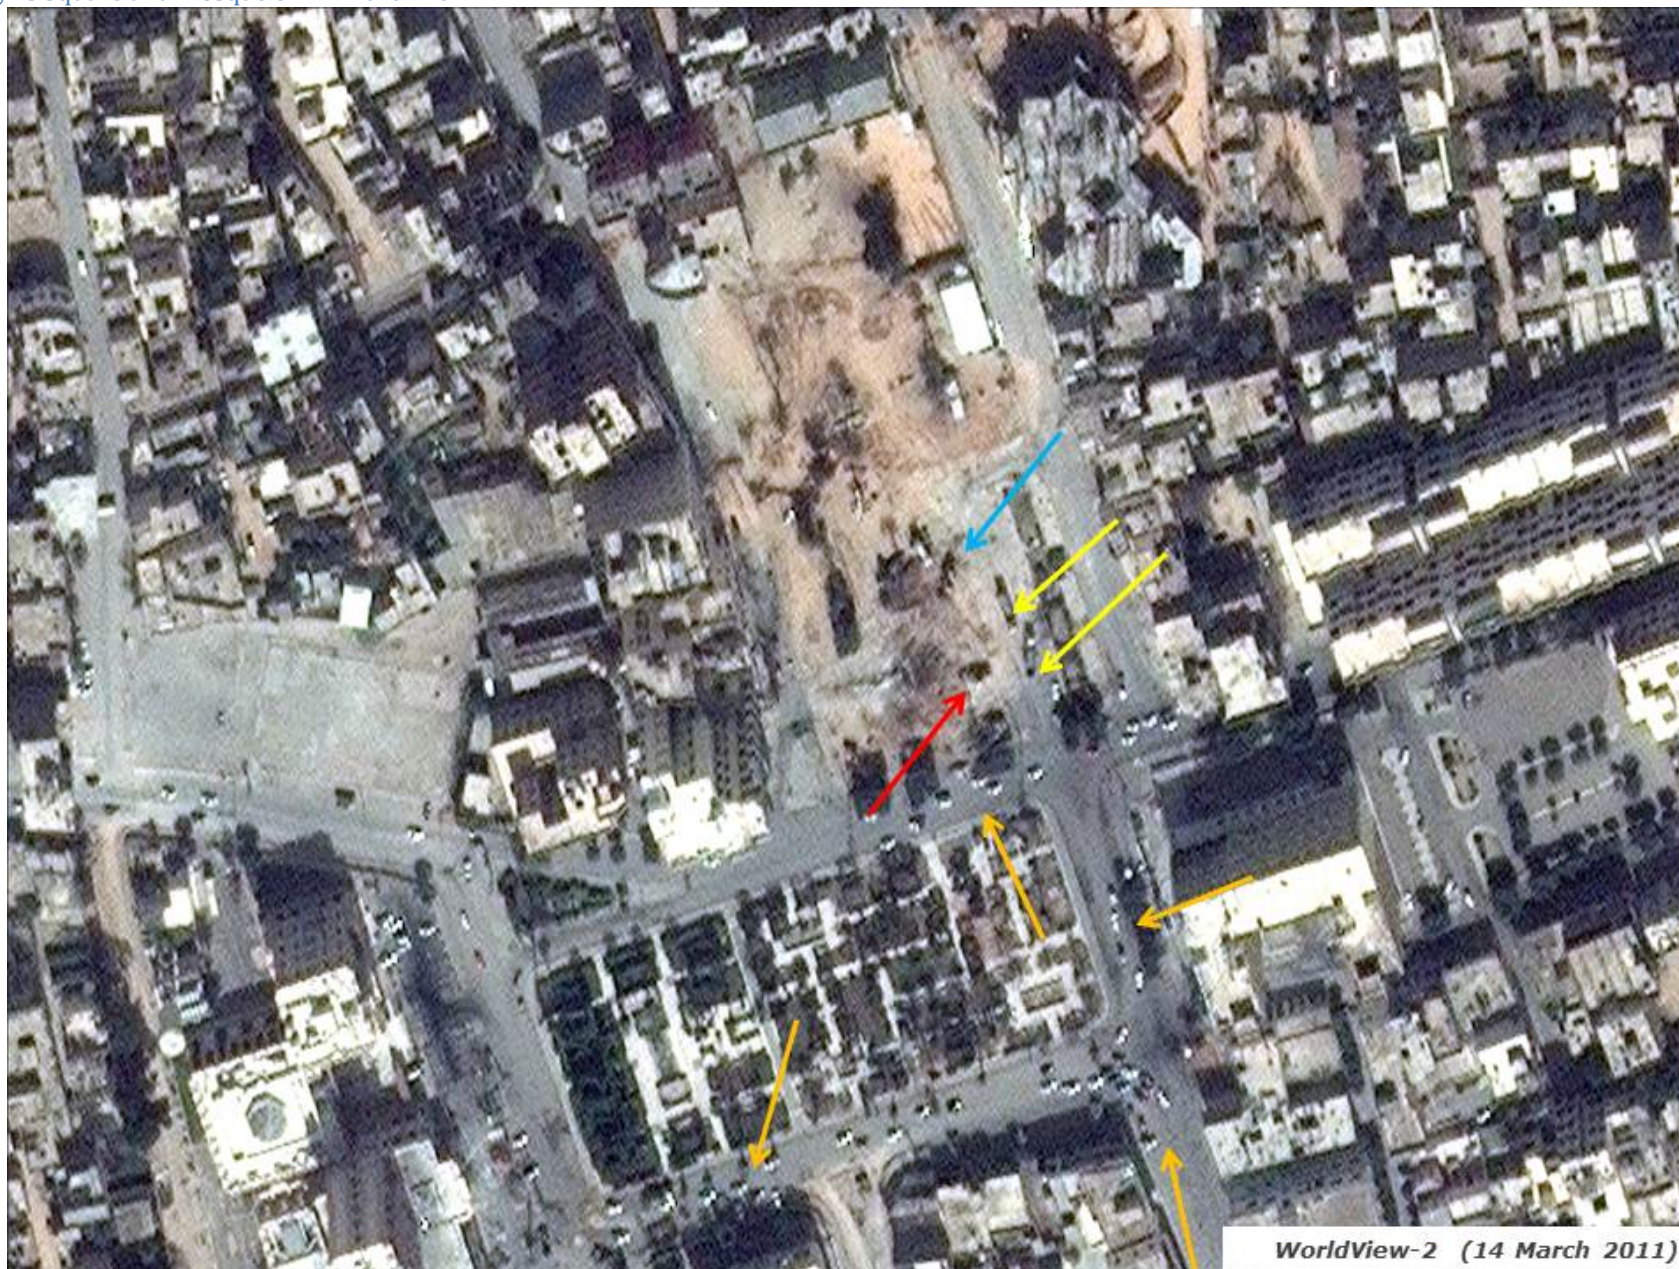
Figure 23. Martyr's Square and mosque on 14 March 2011

Martyr's Square after capture by pro-Gadaffi forces on 14 March 2011. The mosque has been removed (red arrow) and a front end loader is visible (blue arrow), as well as dump trucks (yellow arrows). Several groups of light trucks are also present in and around the square (orange arrows).

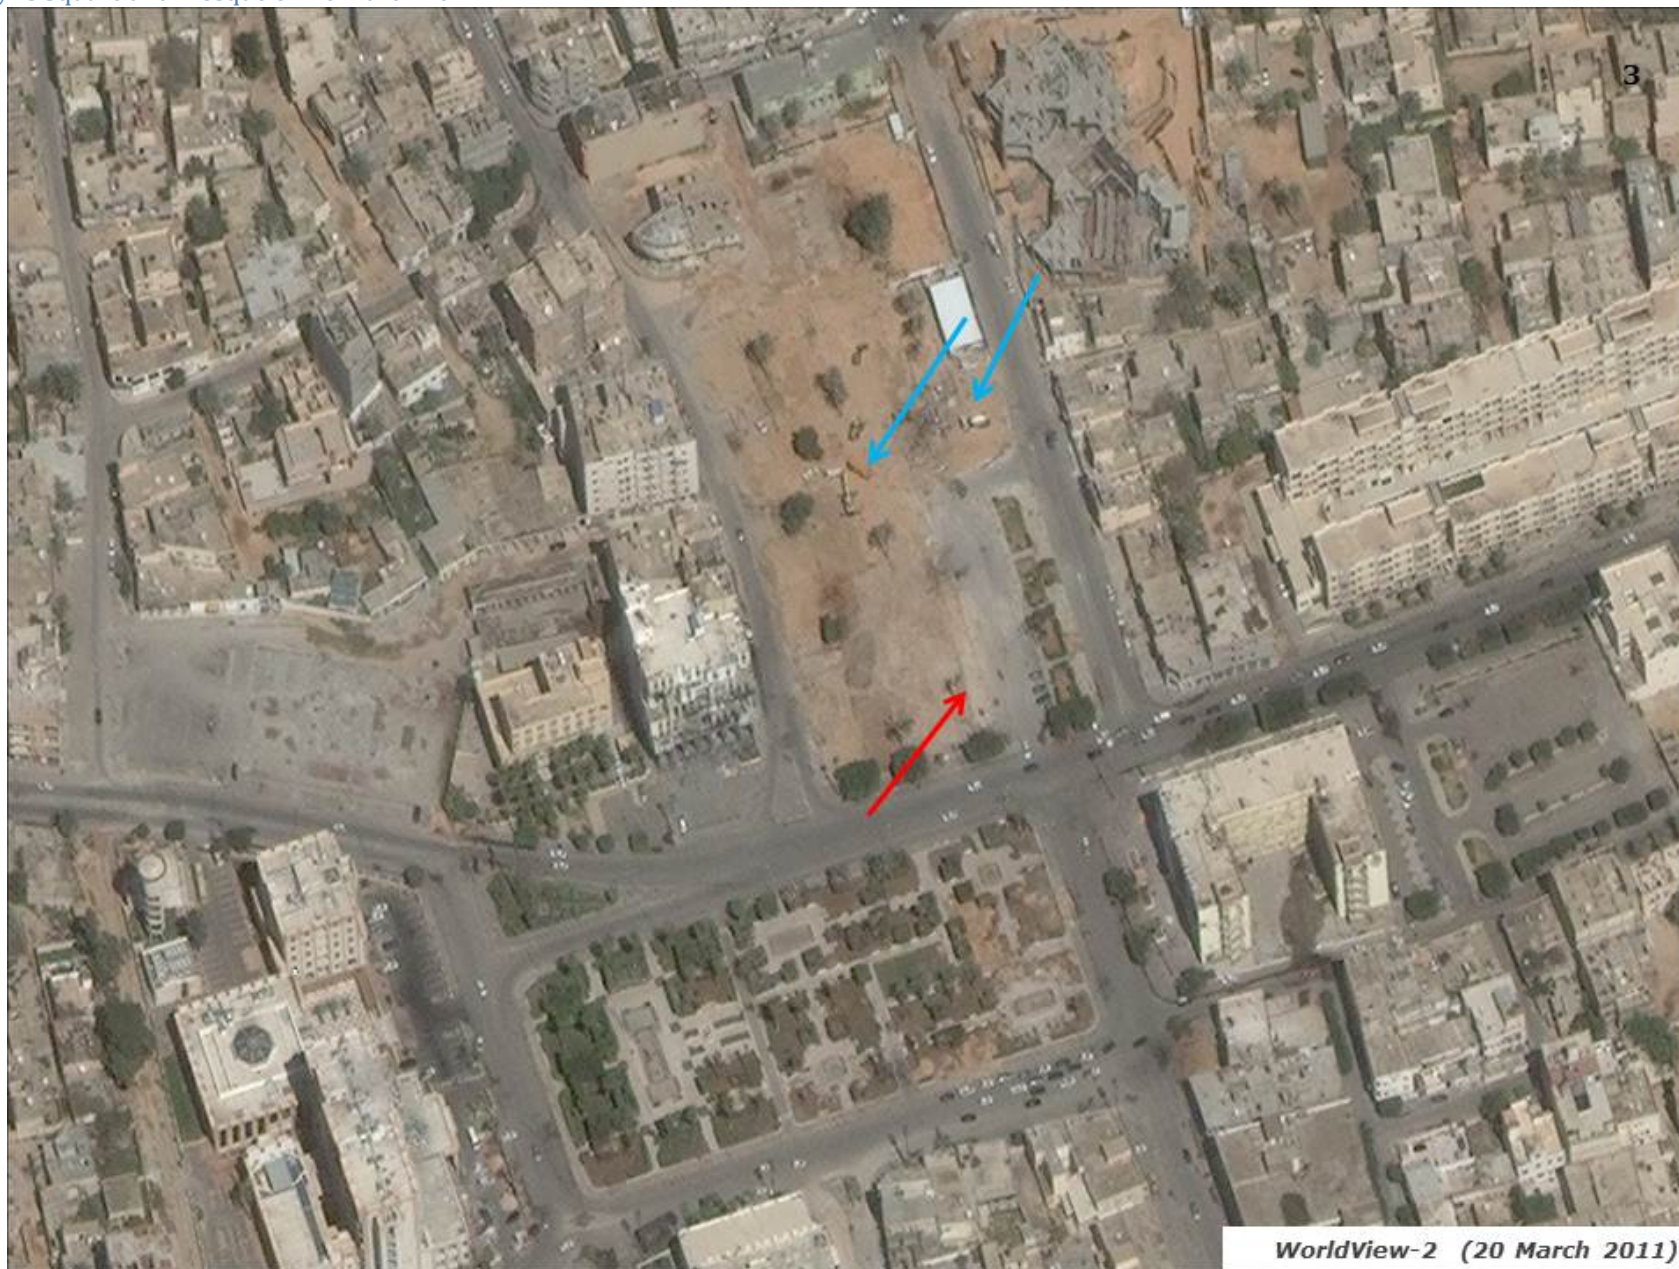
Figure 24. Martyr's Square and mosque on 20 March 2011

A higher quality image showing Martyr's Square on 20 March 2011. The area of the razed mosque is indicated by a red arrow, and several heavy construction vehicles are visible (blue arrows). Numerous light trucks are also visible in and around the square.

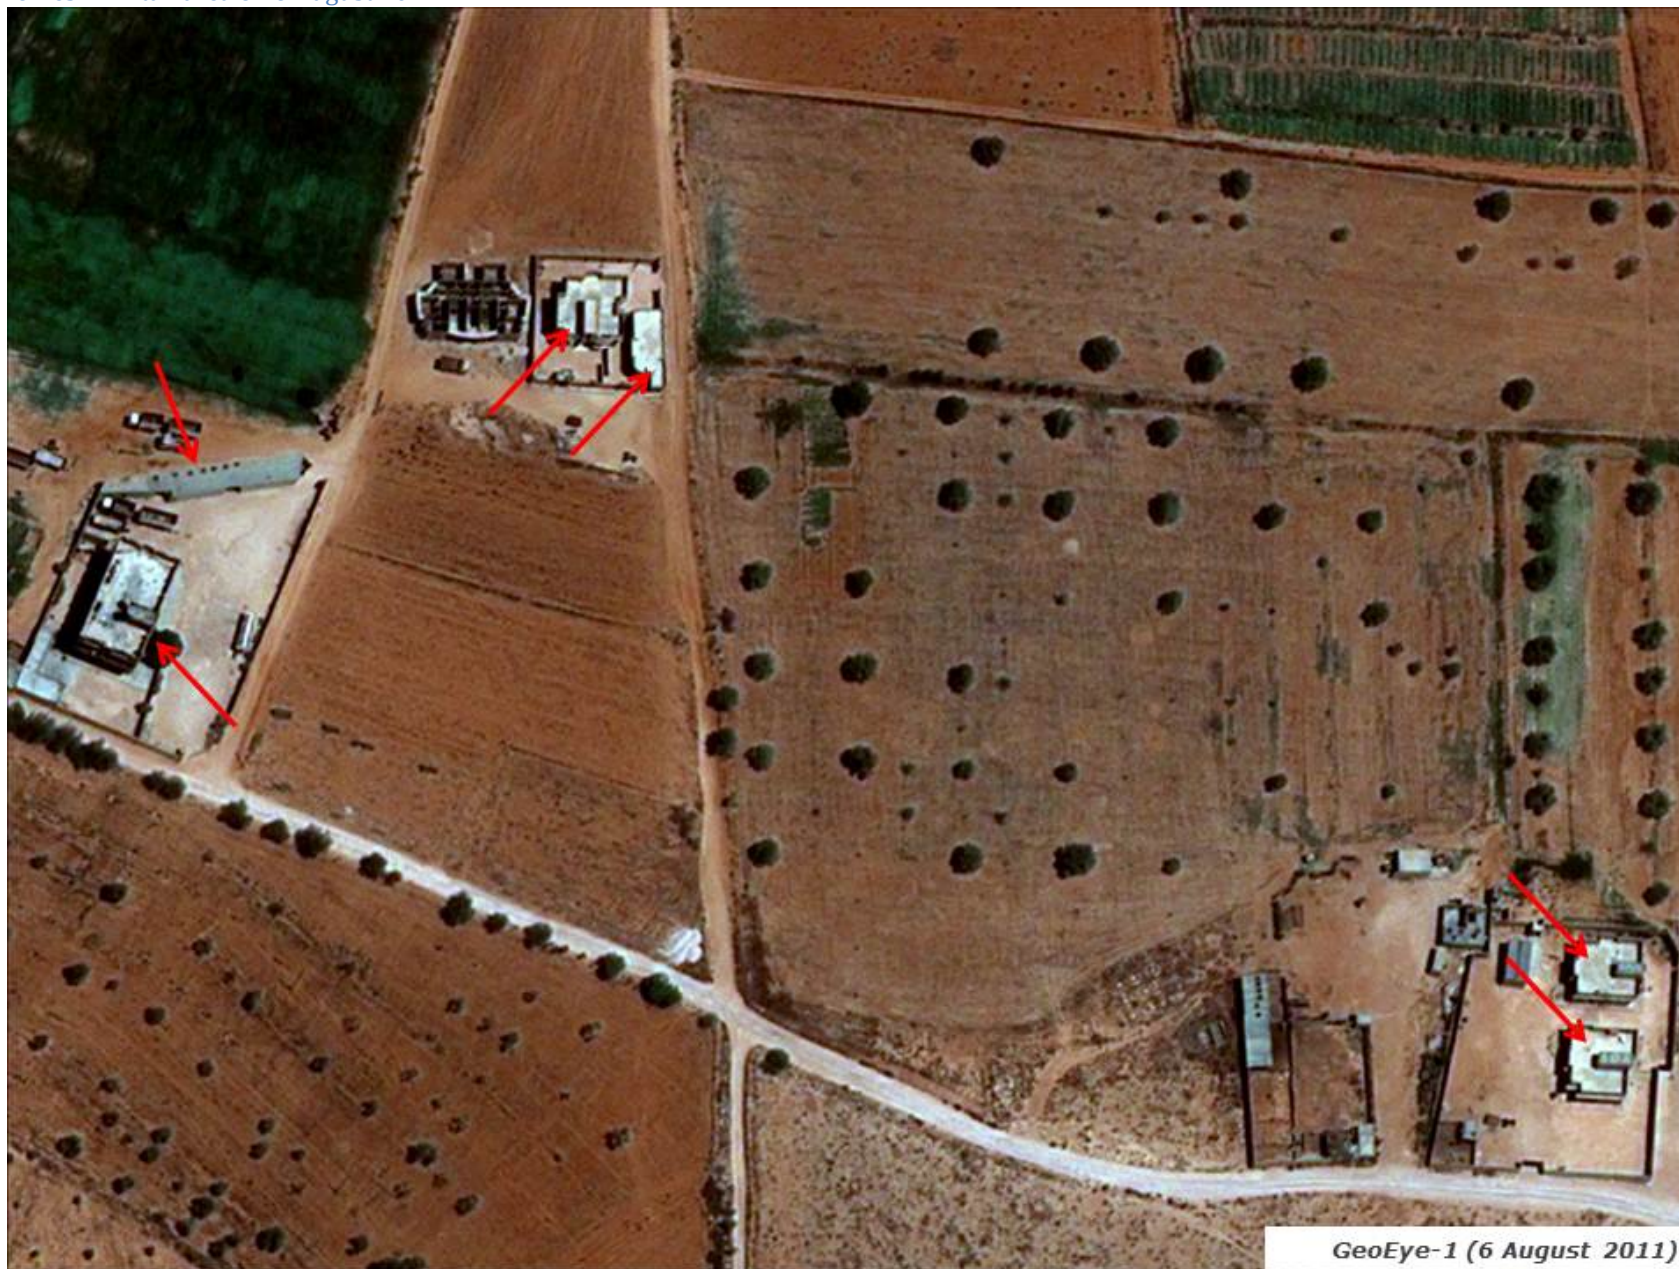
Figure 26. Four homes in Ziltan area on 6 August 2011

Homes and outbuildings (red arrows) targeted by airstrikes as seen on 6 August 2011.

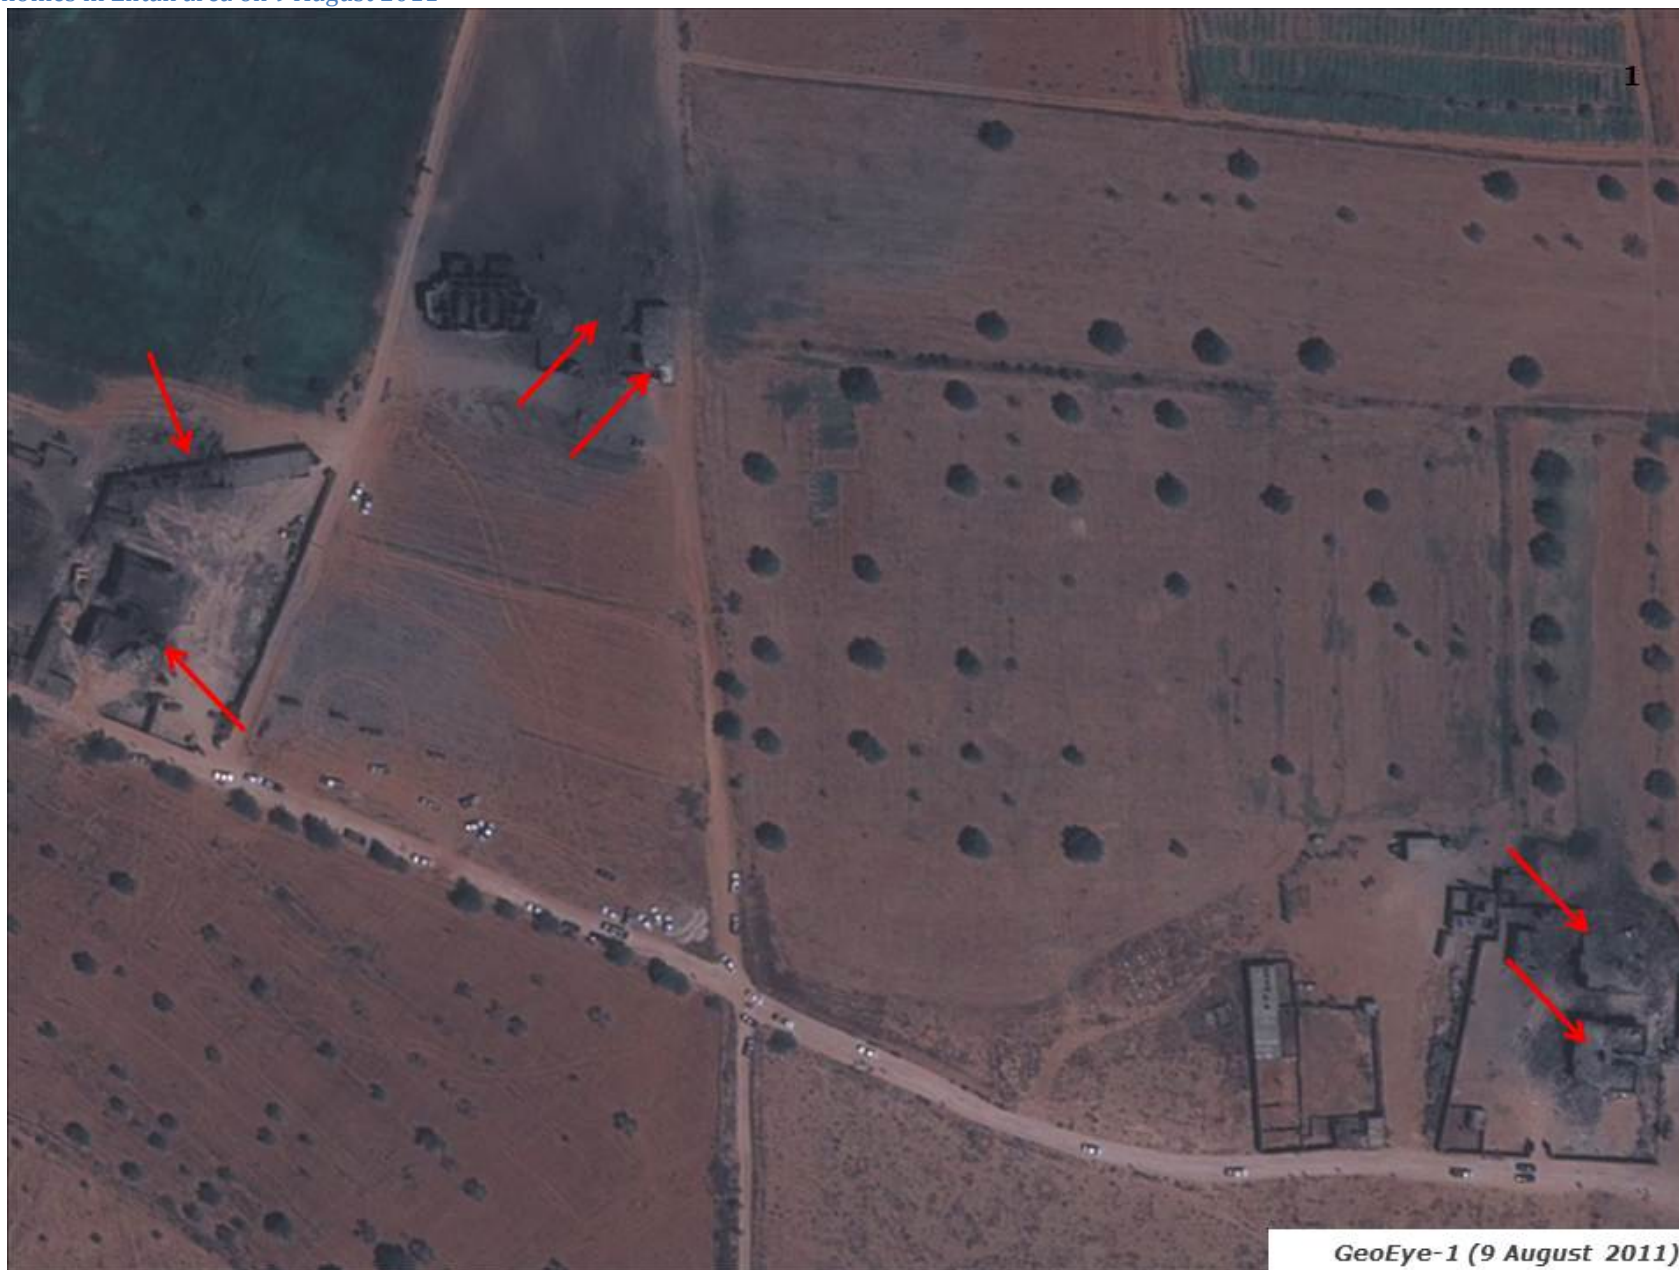
Figure 25. Four homes in Ziltan area on 9 August 2011

Multiple homes and structures in this area were destroyed or severely damaged (see red arrows) as seen in this image from 9 August 2011. Circular patterns of scorching, especially in the top left destroyed structure, are consistent with significant explosions.
