Satellite Imagery and the Libyan Conflict

***A report prepared for the International Commission of
Inquiry on Libya, Office of The High Commissioner for
Human Rights***

February 23, 2012 – Version 2.0

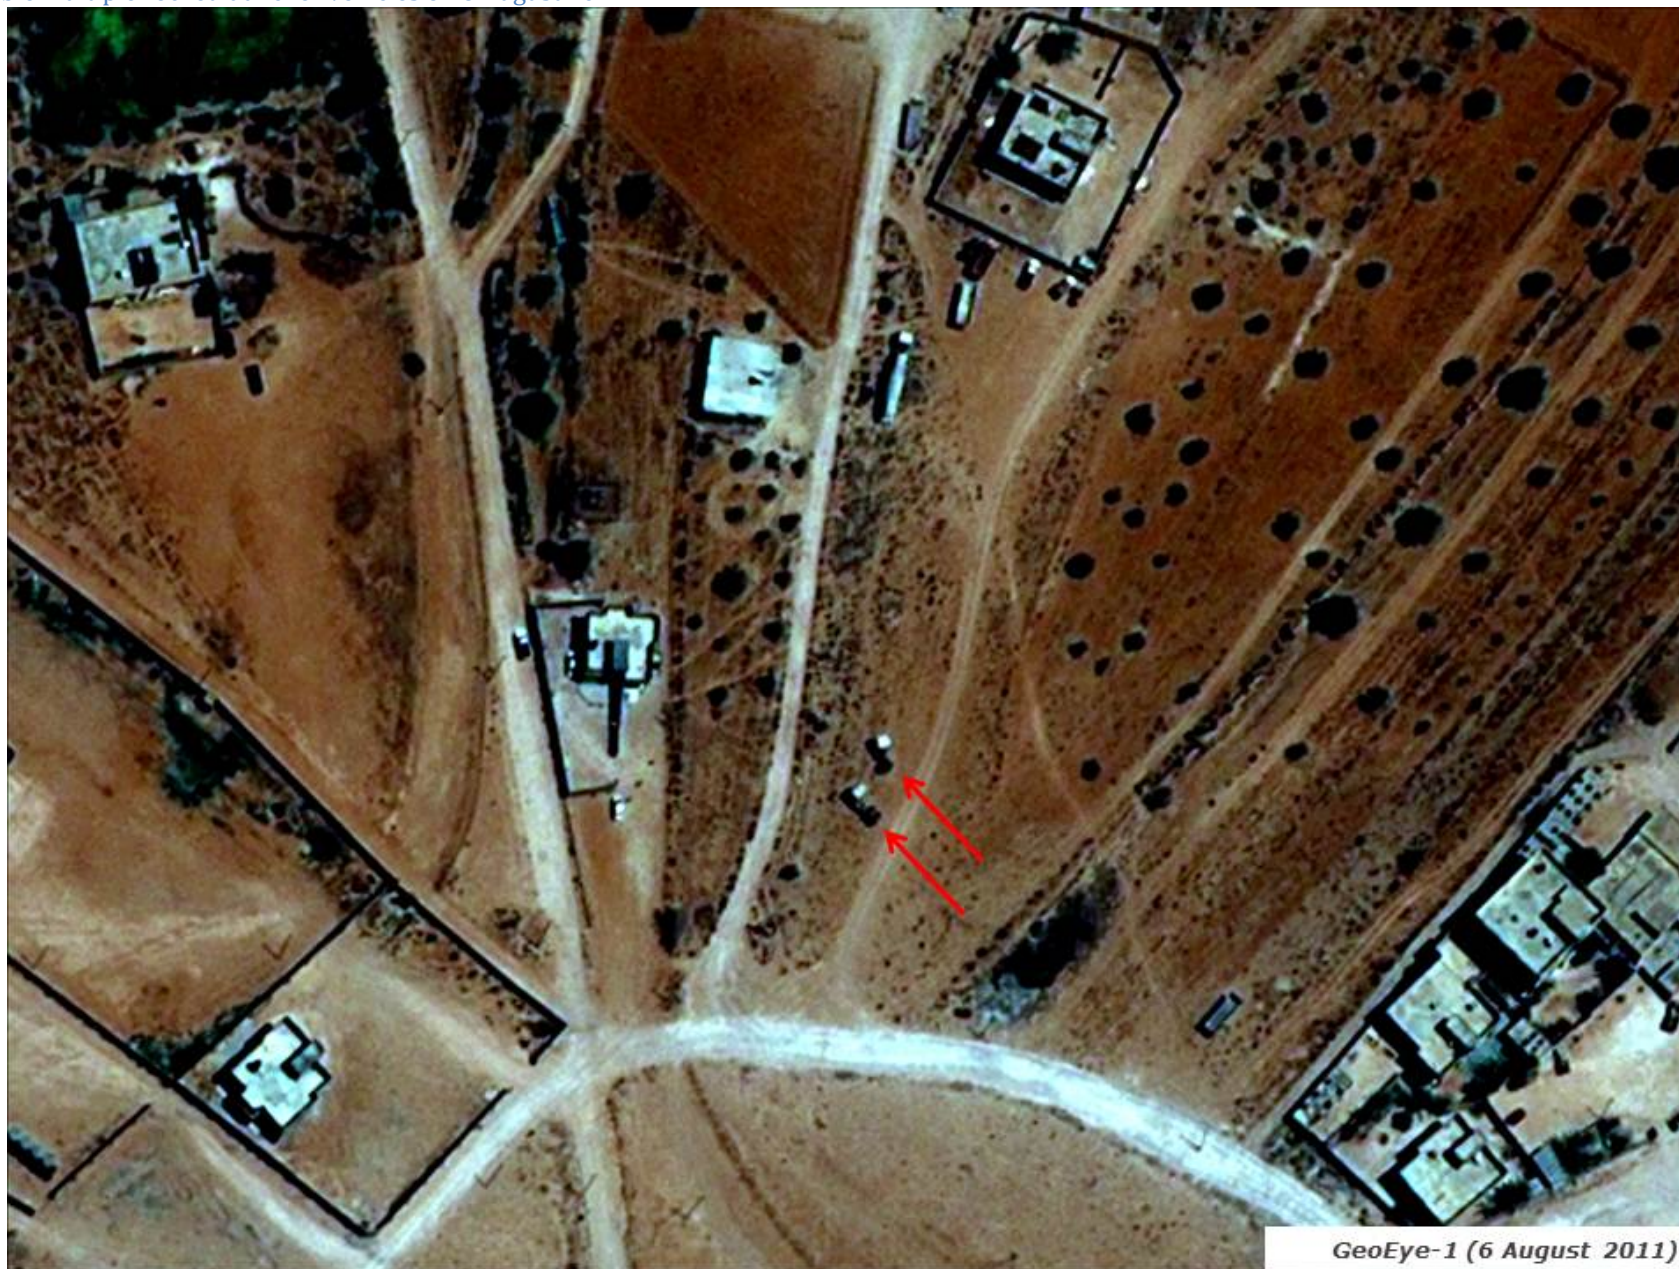
Figure 27. Possible multiple rocket launcher vehicles on 6 August 2011

Two possible multiple rocket launcher vehicles (red arrows) with firing tubes elevated. These vehicles are located 1700 meters southwest of the targeted buildings and oriented towards the southeast. Vehicles are visible in almost the exact same position on both 6 and 9 August 2011.

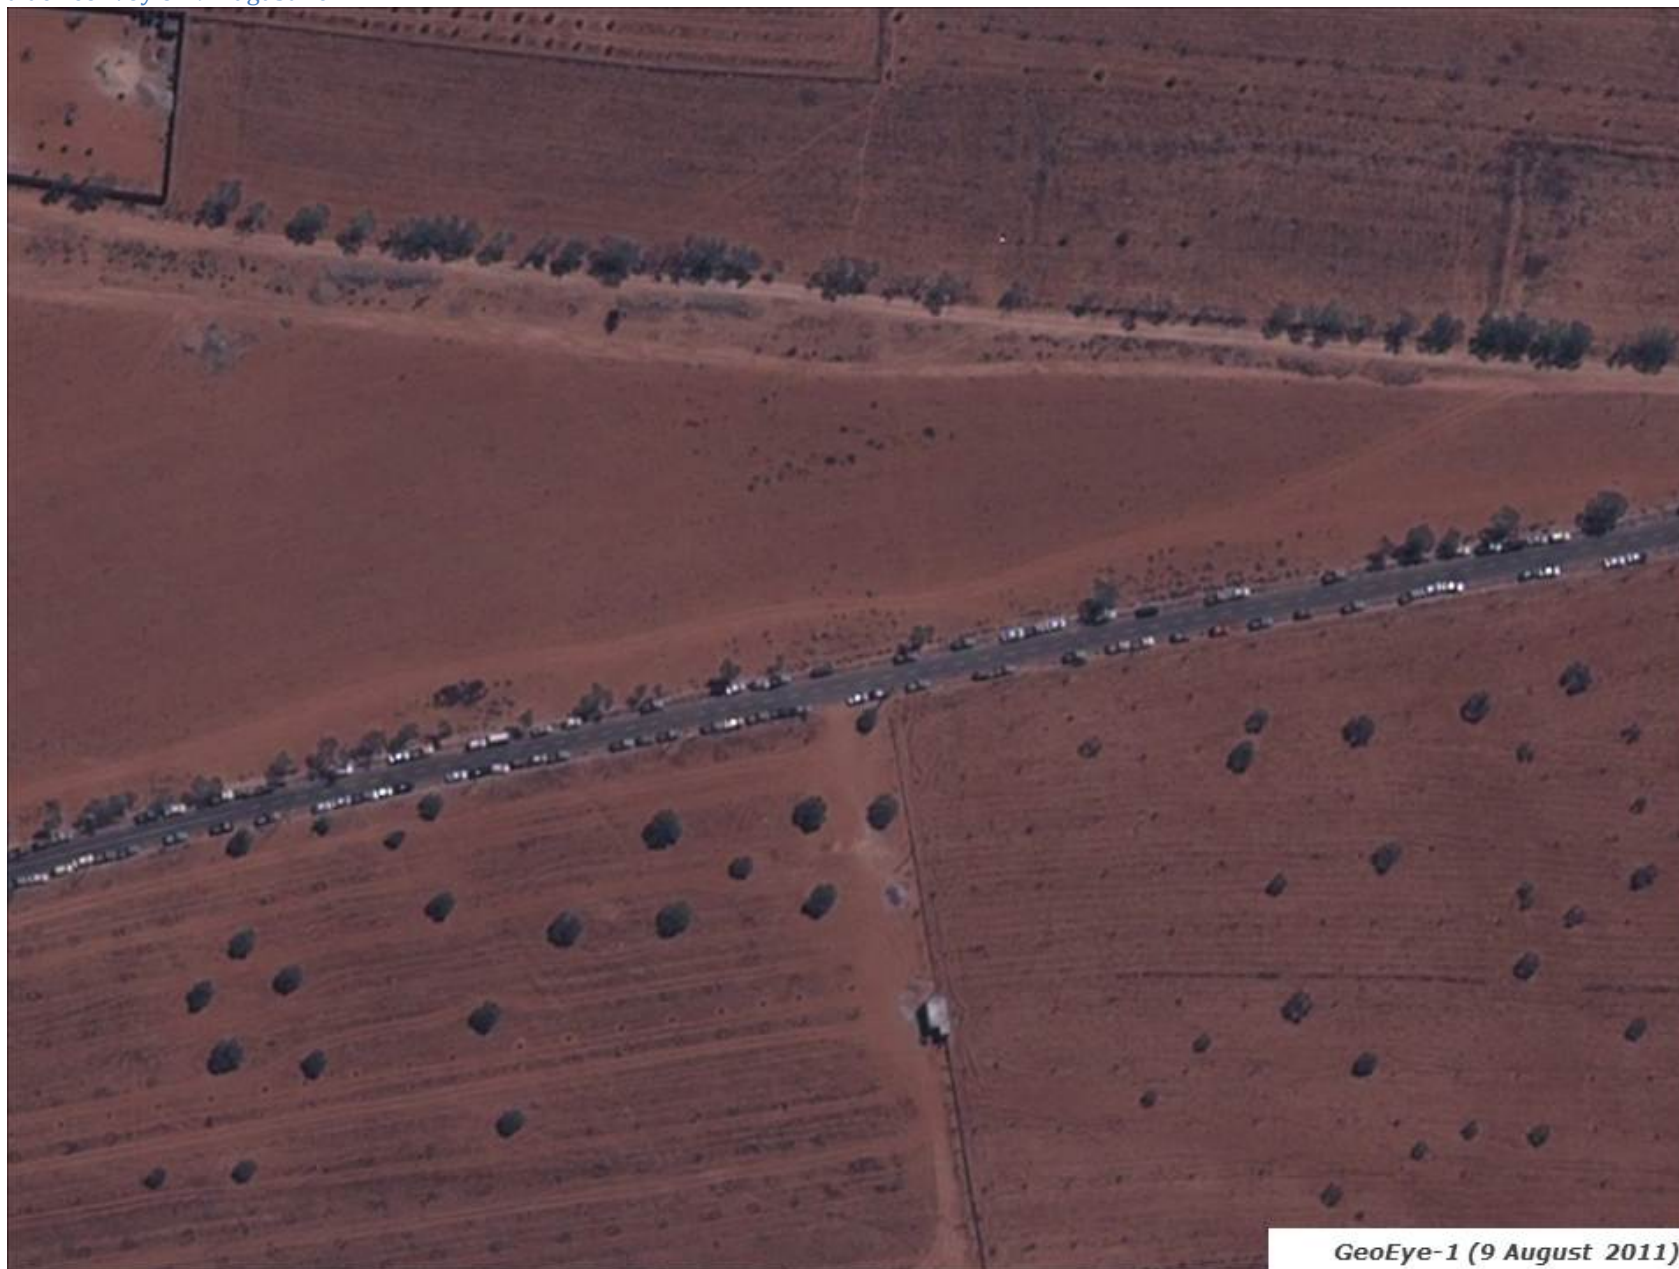
Figure 28. Light truck convoy on 9 August 2011

This line of light trucks stretched for more than 500 meters and is located less than one kilometer north of the destroyed homes shown in previous pages. The trucks are visible in imagery from both 6 and 9 August 2011. Image has been rotated 90 degrees for presentation purposes.

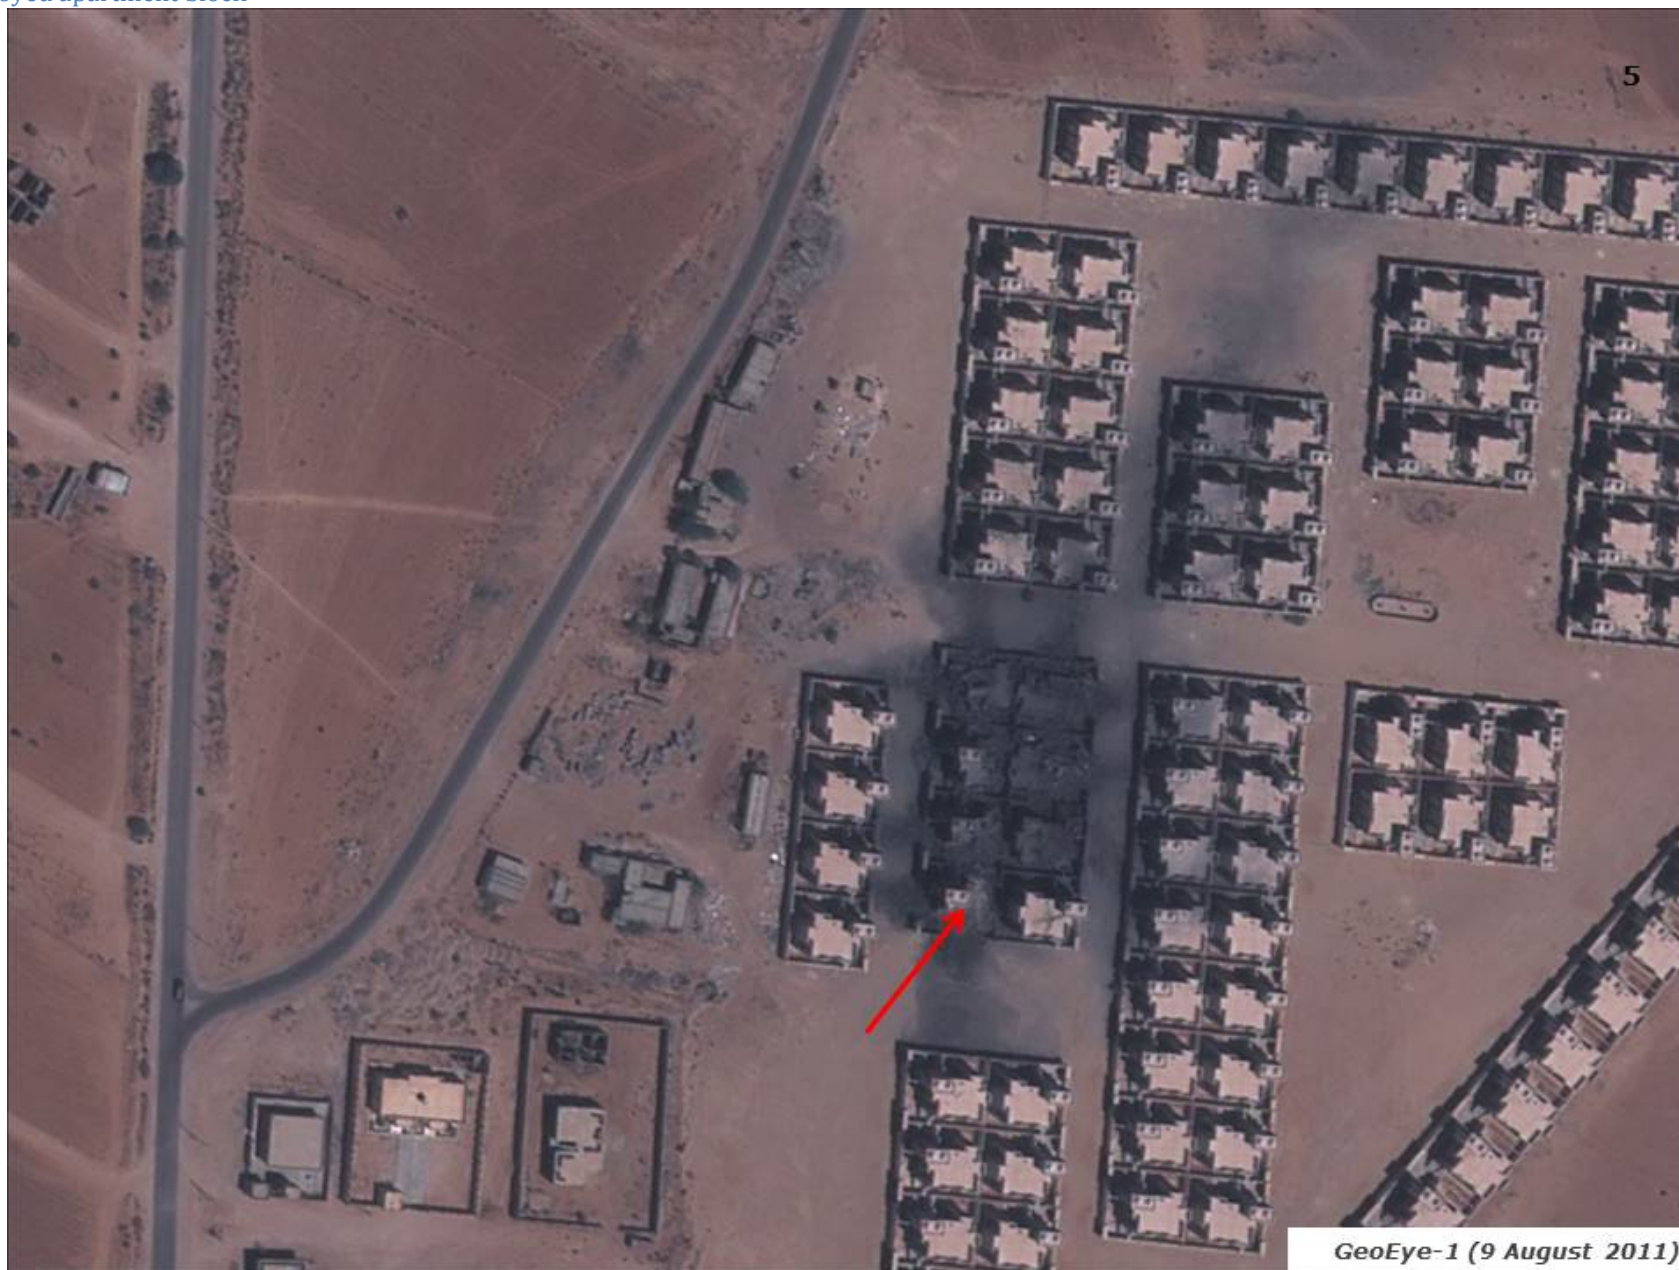
Figure 29. Destroyed apartment block

A block of apartment buildings were destroyed (see red arrow) between 6 and 9 August 2011. Four buildings were completely destroyed and collapsed, three others were severely damaged, and one likely suffered significant fire damage.

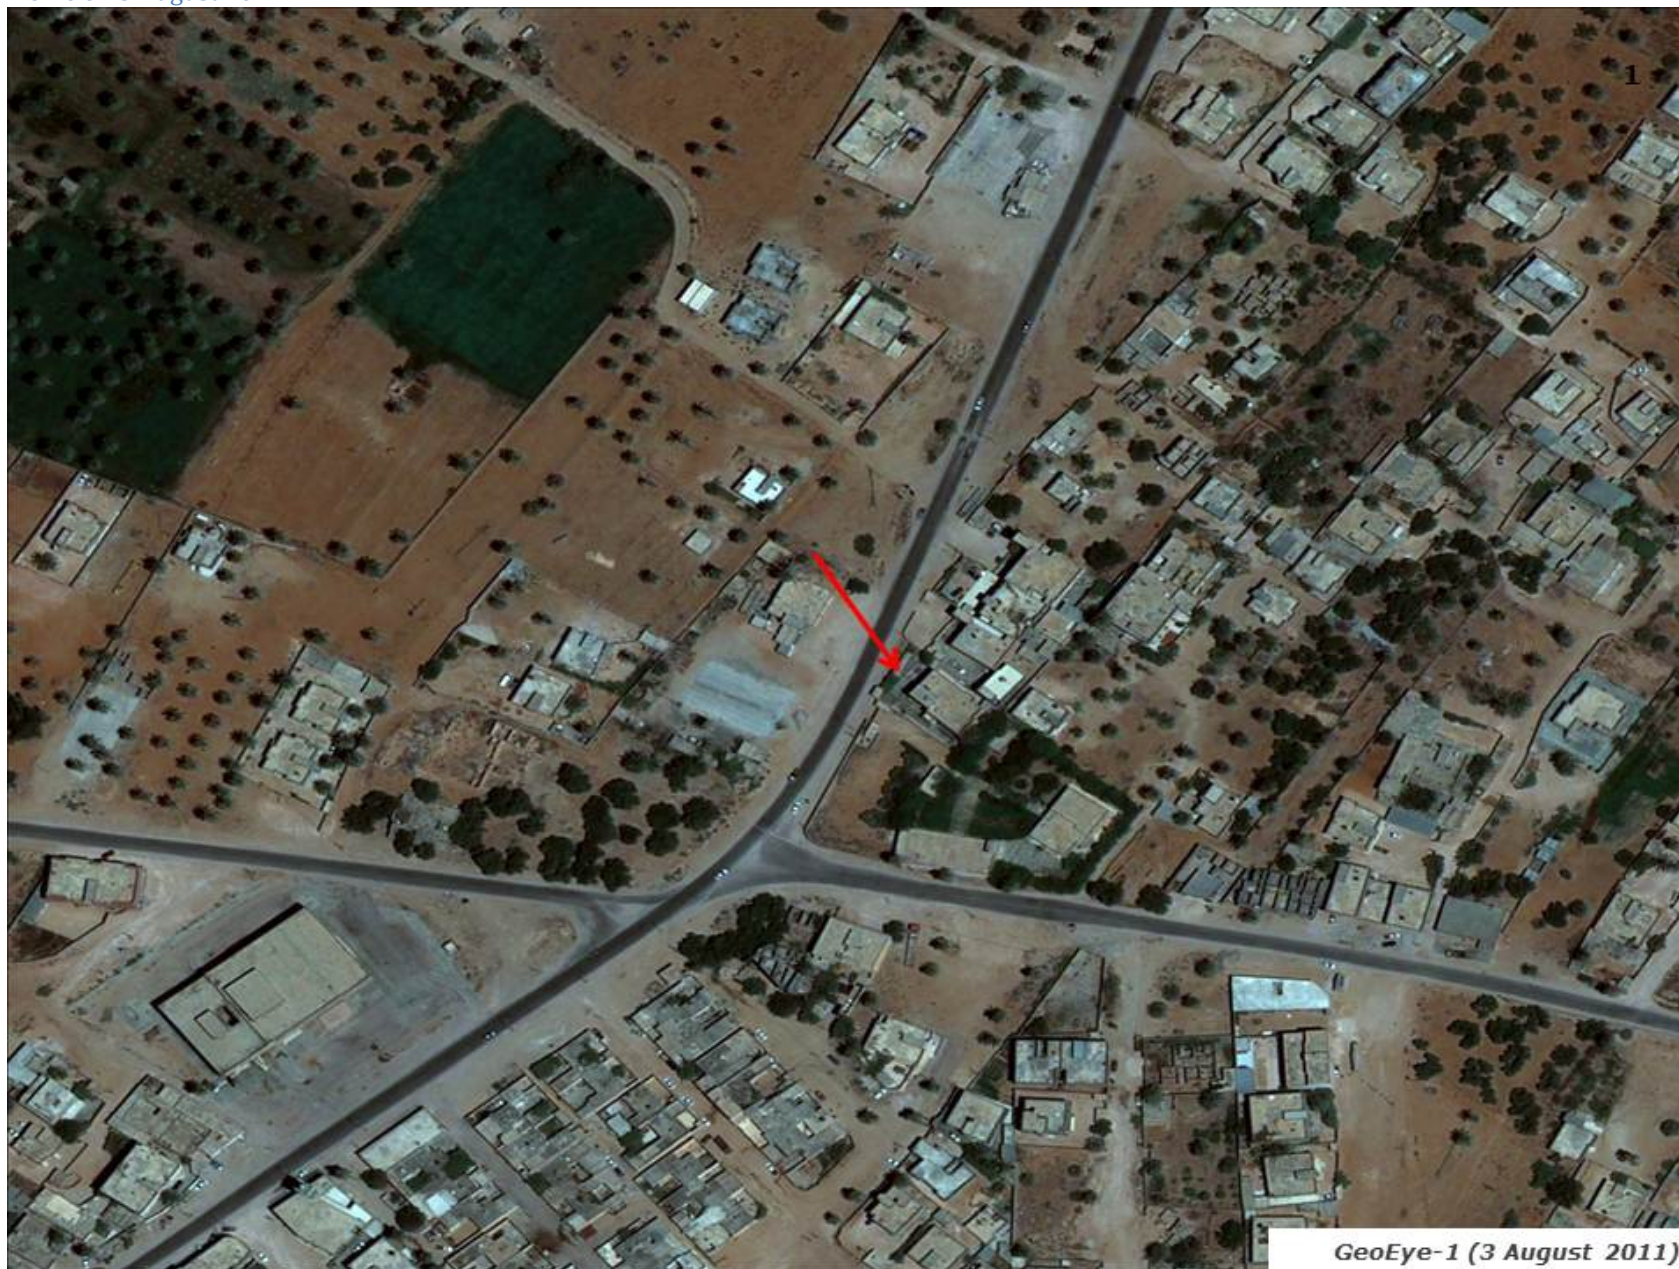
Figure 30. Ziltan home on 3 August 2011

The location in question (see red arrow) on 3 August June 2011. Structure is intact and the rooftop clearly delineated.

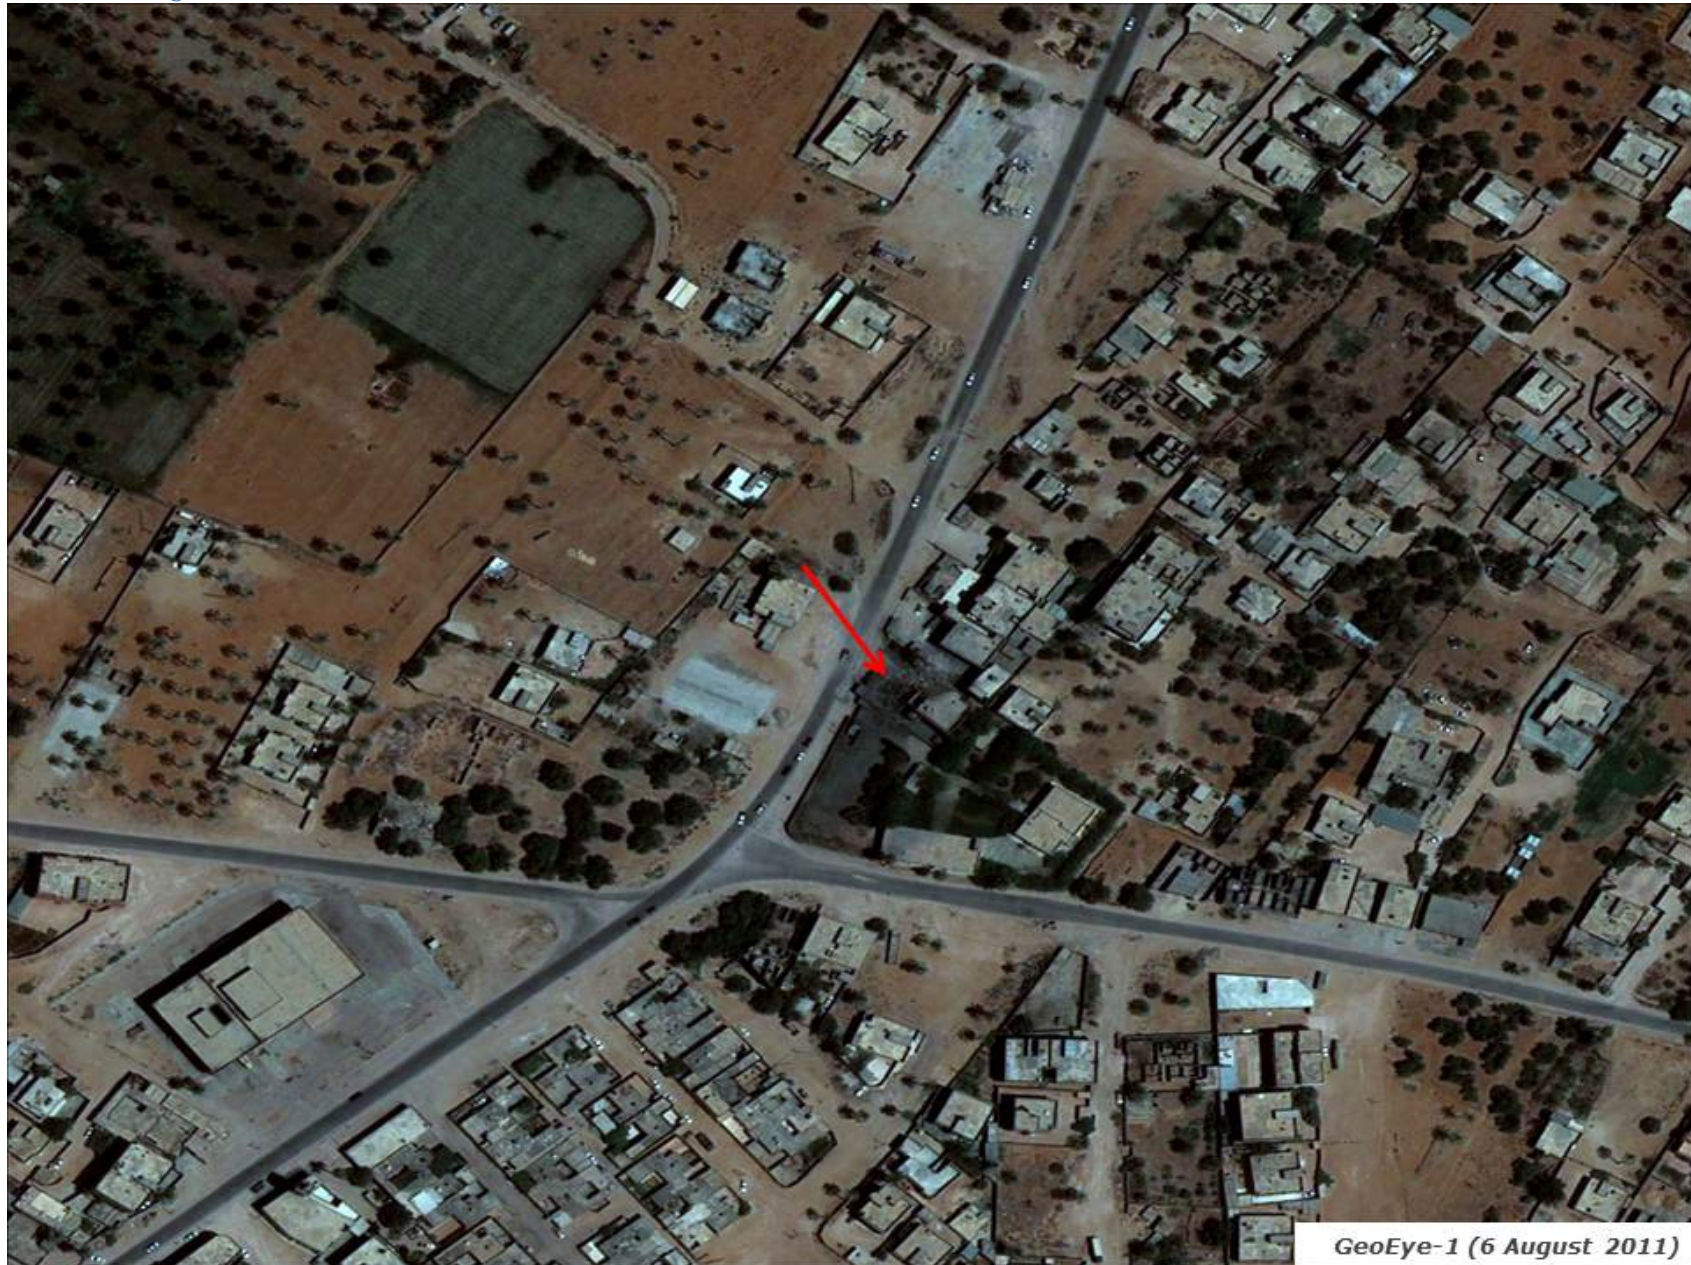
Figure 31. Ziltan home on 6 August 2011

The location in question (red arrow) on 6 August 2011. The image clearly shows heavy damage and partial collapse of the structure. Multiple light trucks are also now visible on the proximate road.

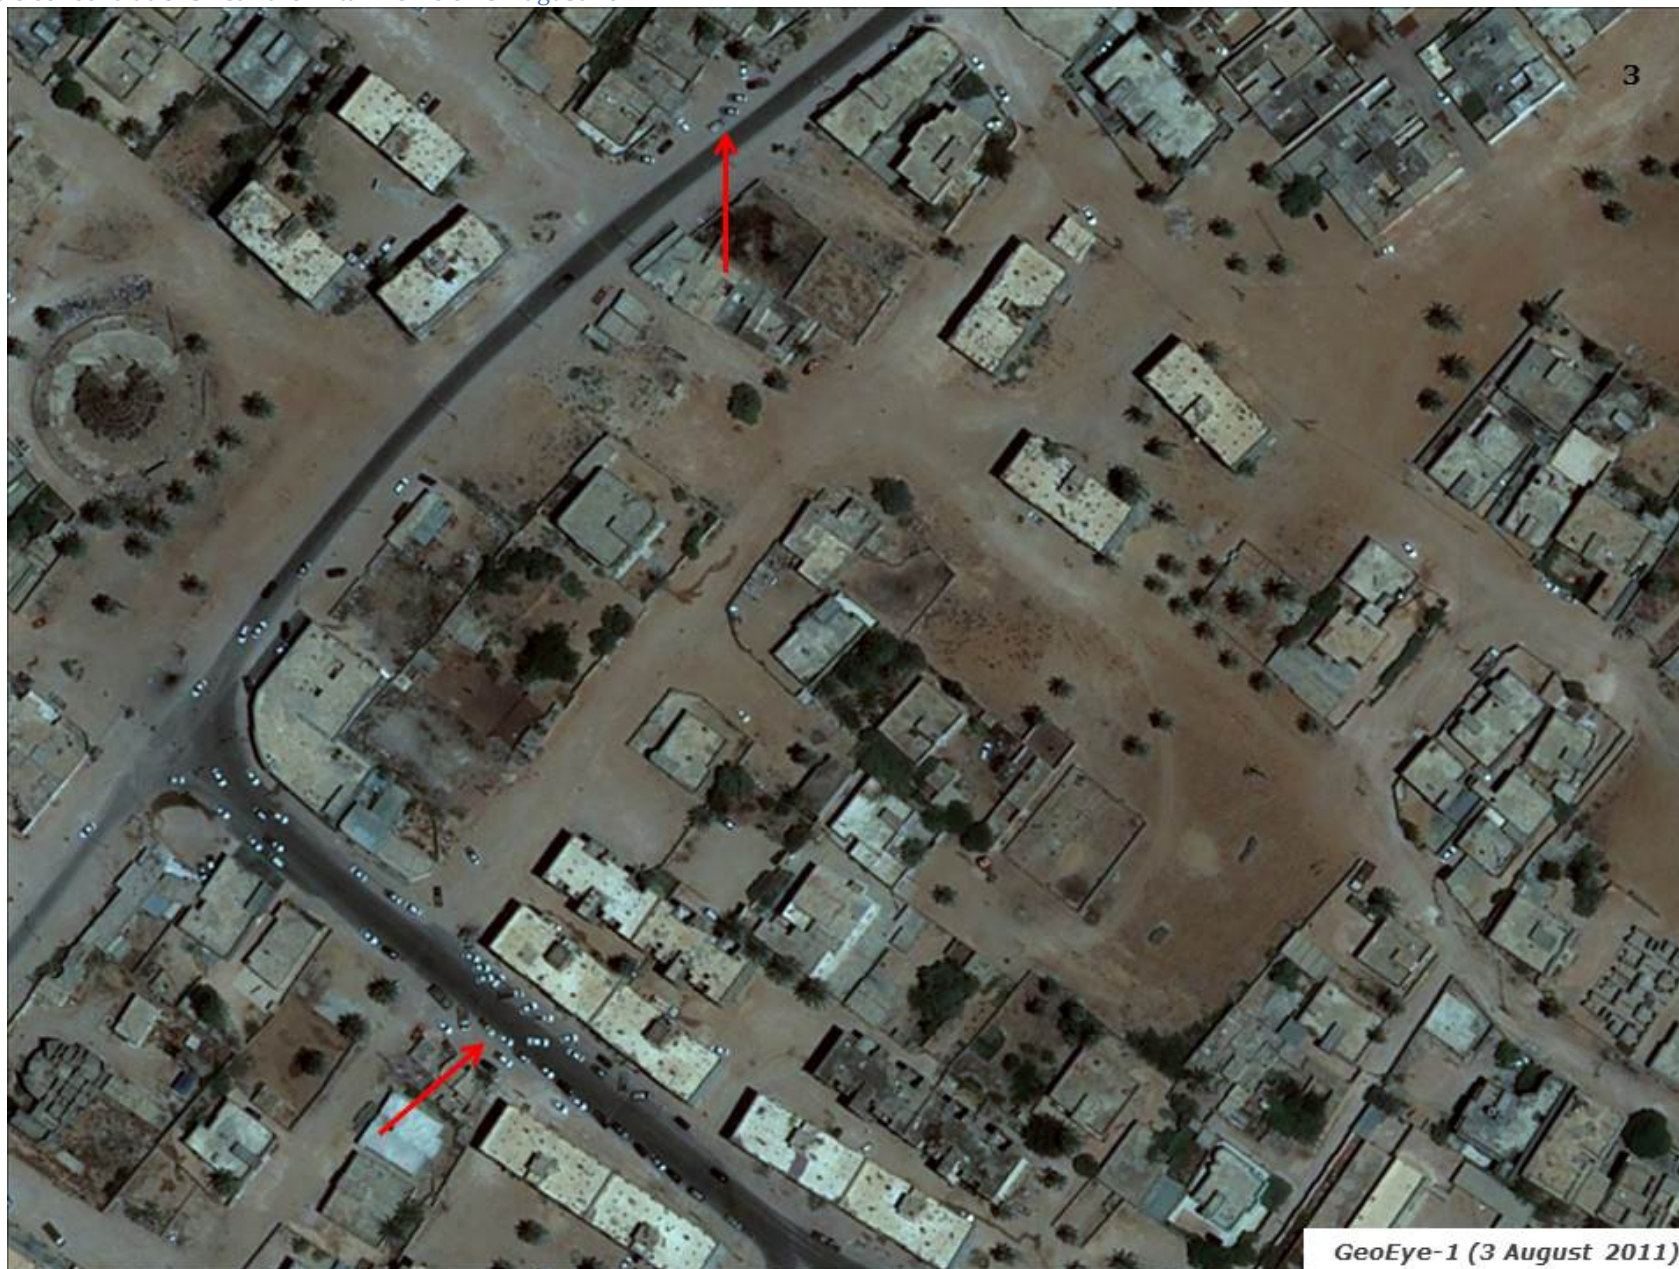
Figure 32: Vehicle concentrations near the Ziltan home on 3 August 2011

Two areas of vehicle concentrations (red arrows) located 400 meters southwest of the targeted house on 3 August 2011. Imagery from 2009 also shows large numbers of vehicles in this area, suggesting it may be a market area or similar community gathering point.

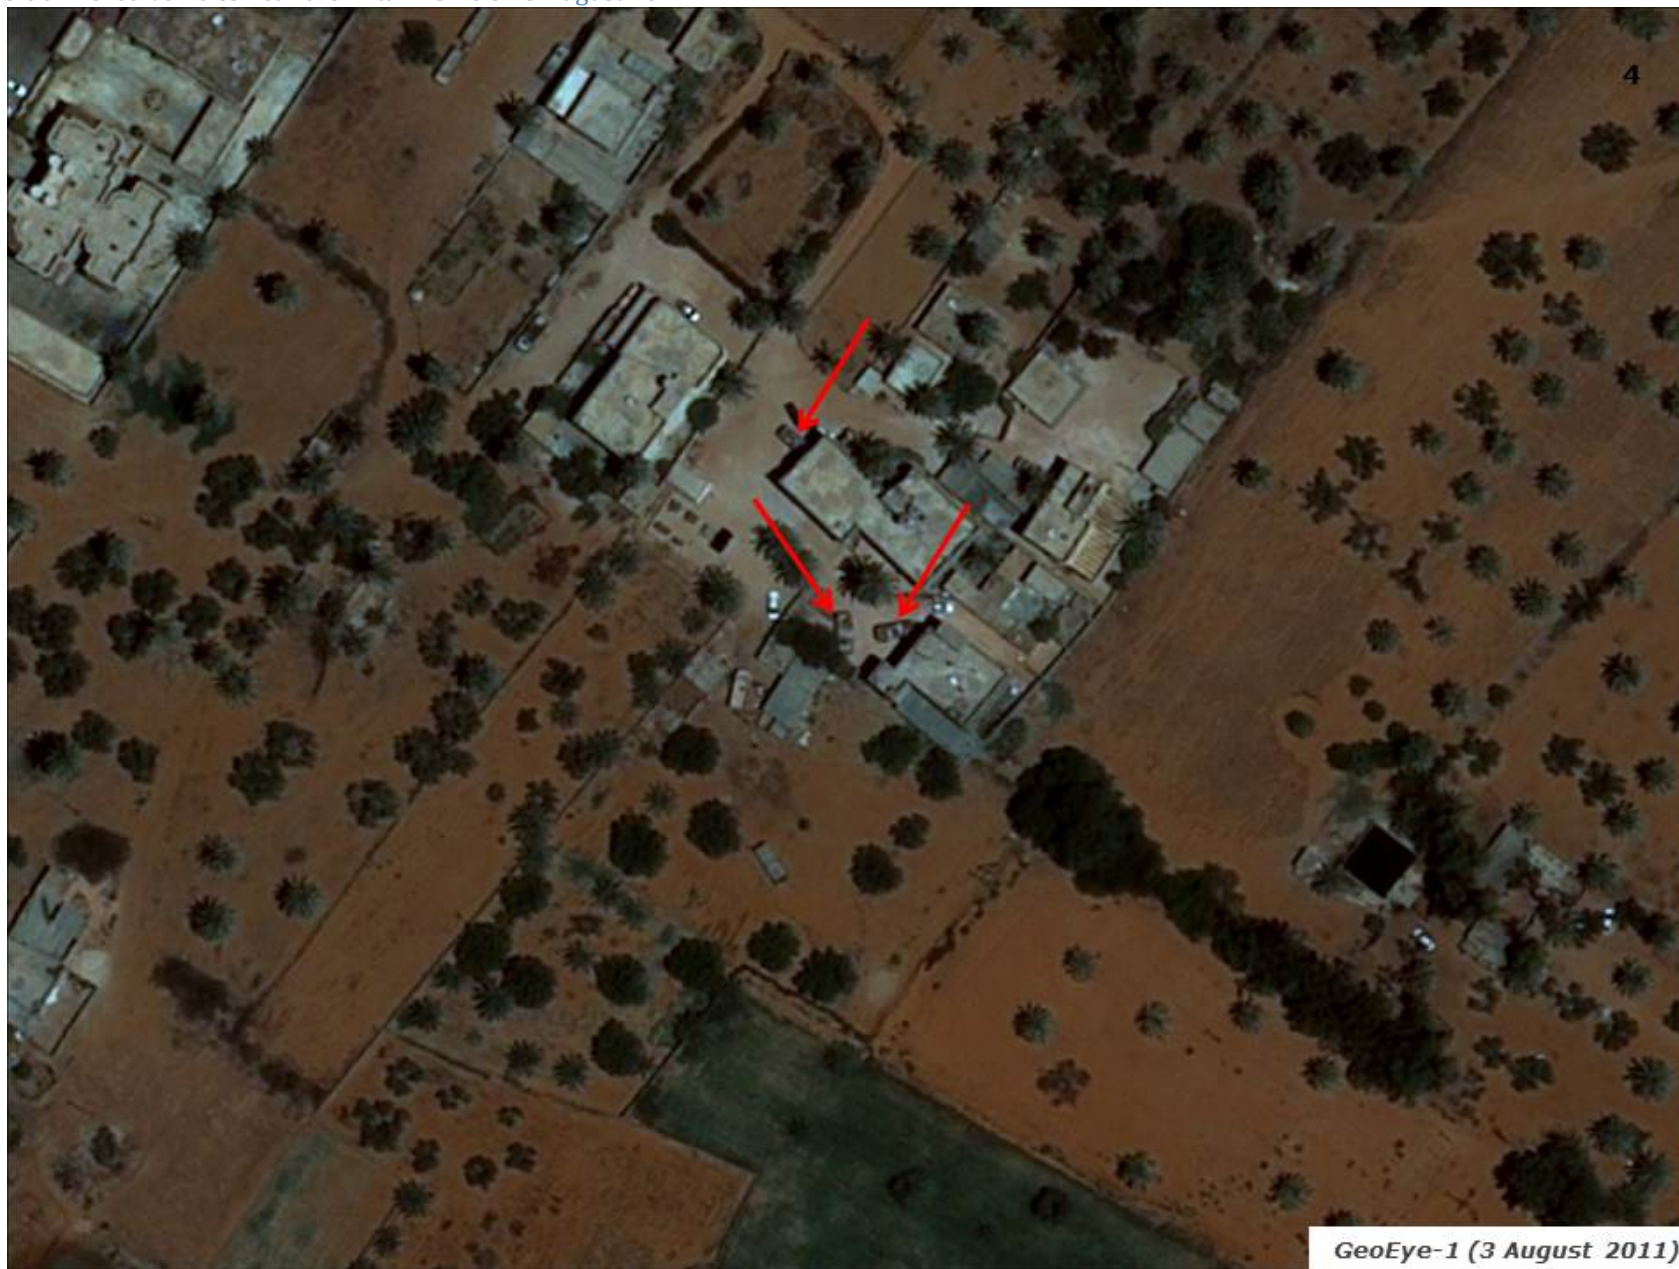
Figure 33: Possible armored vehicles near the Ziltan home on 3 August 2011

Several possible armored vehicles (red arrows) located about 2.4 kilometres west of the targeted building on 3 August 2011. Dimensions are consistent with BMP type infantry fighting vehicles and they are no longer present by 6 August. Multiple light trucks are also visible.

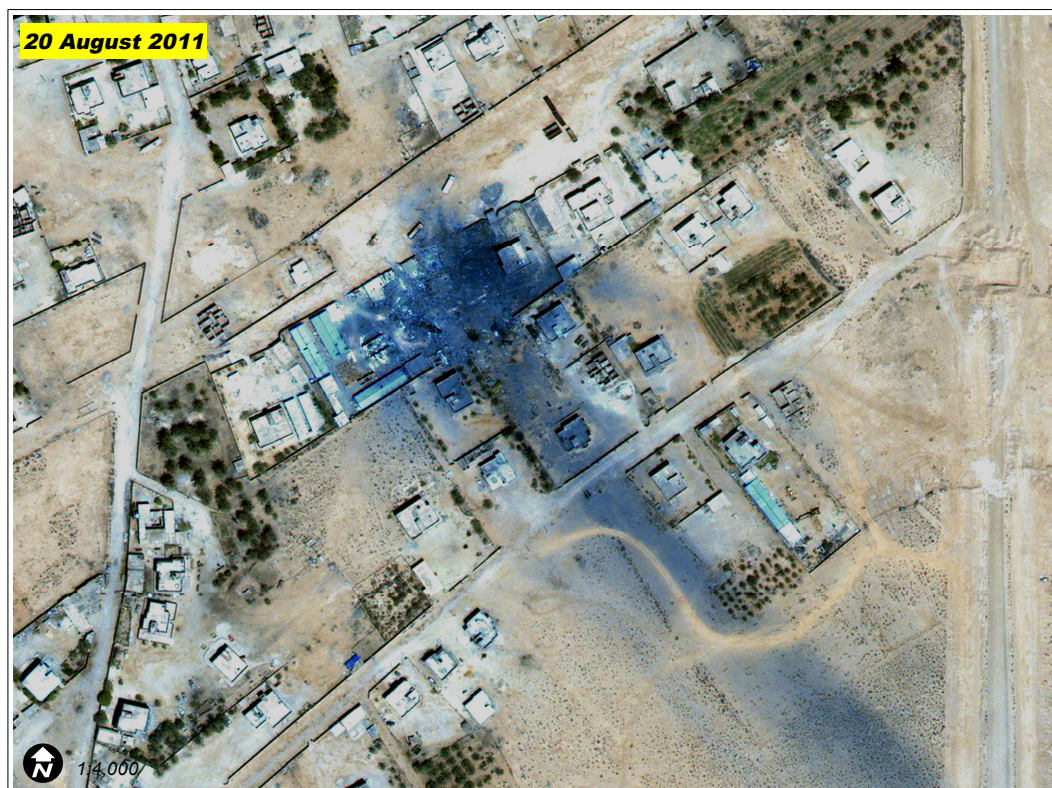
Remnants of buildings and evidence of burning in Tawerga.

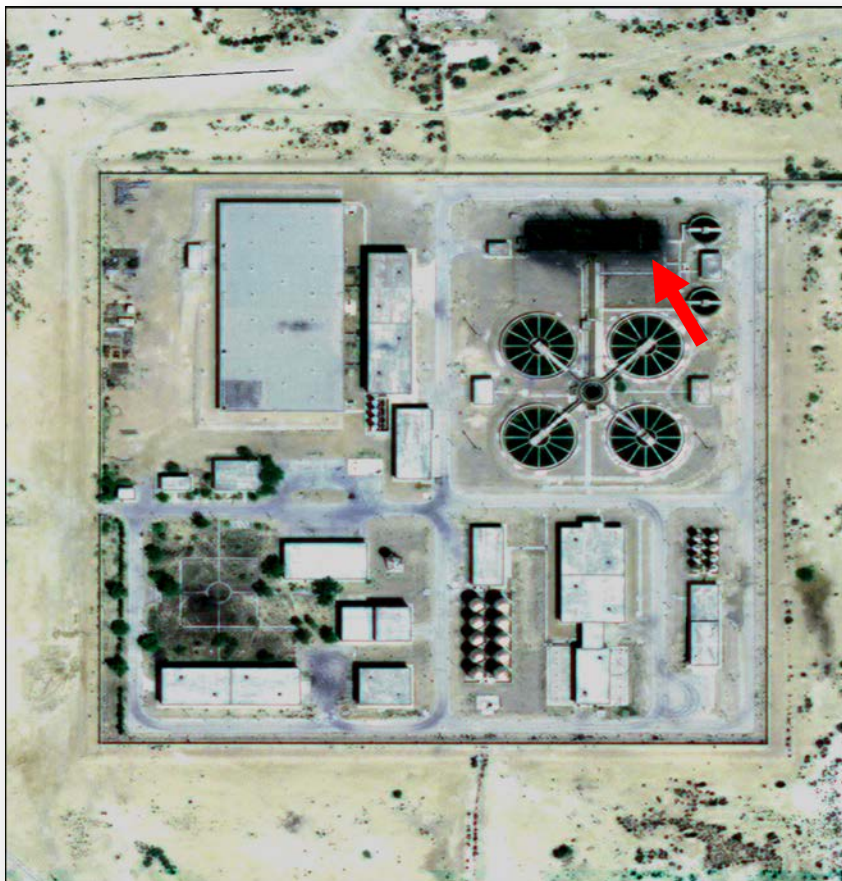
Figure 1 - Wastewater treatment facility with cooling towers destroyed (red arrow) by 20 August 2011

Between 12 June 2009 and 20 August 2011 a total of 49 structures were identified as destroyed or damaged in Tawerga. Multiple facilities such as warehouses, industrial areas, and individual buildings are clearly destroyed and often showing indications of fire. An apparent wastewater treatment facility shows selective destruction of its cooling tower facilities by 20 August (see Figure 1). In addition, several armored vehicles and concentrations of light trucks are also apparent in the 20 August satellite image (see Figure 2).

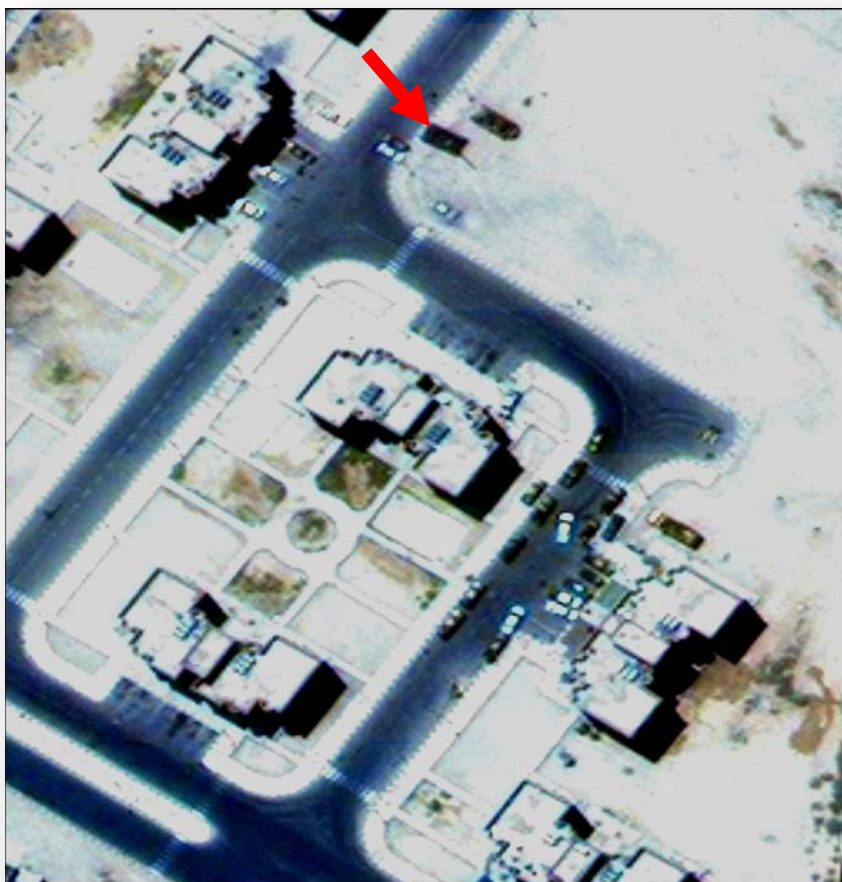
Figure 2 – Tank (red arrow) and other vehicles in Tawerga on 20 August 2011

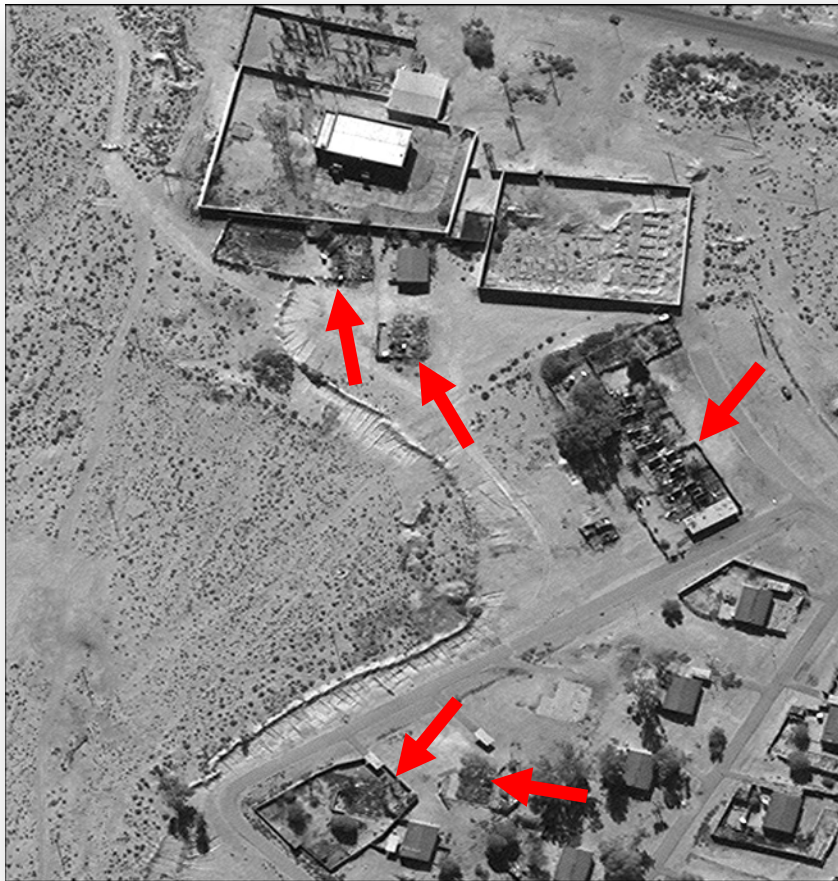
Figure 3 – Multiple structures destroyed by 24 November 2011 (indicated by red arrows). Structures were intact on 20 August.

Between 20 August and 24 November 2011 an additional 27 buildings were destroyed or damaged (see Figure 3). These buildings largely consist of likely residential and commercial structures. No armored vehicles and few light trucks are visible in the 24 November imagery. A relatively large smoke plume from a fire is visible in central Tawerga (see Figure 4), though it is unclear whether it originates from a building or not. Several groups of construction related vehicles visible in the 20 August image are no longer visible by 24 November 2011.

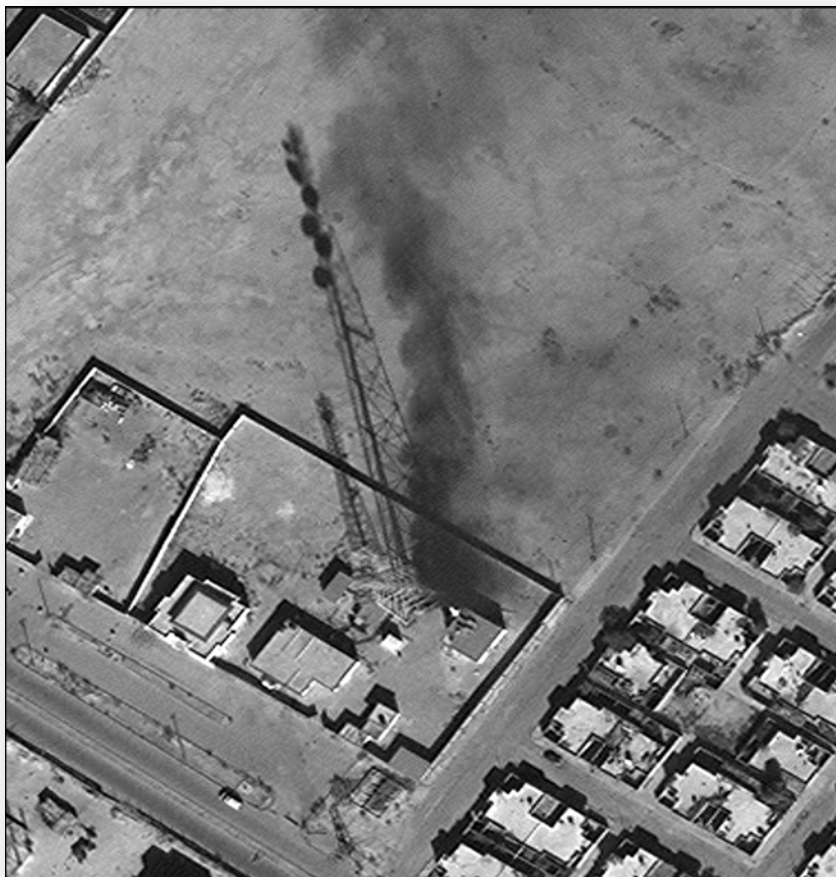
Figure 4 – A smoke plume in central Tawerga. It is unclear whether the proximate building or something else is the source.

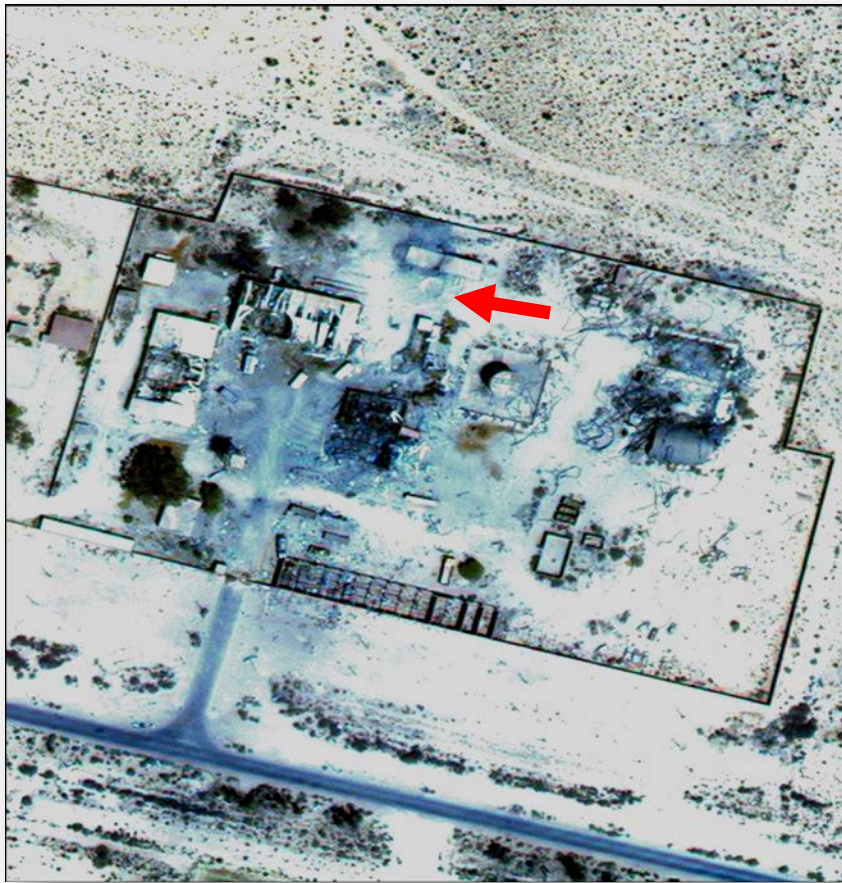
Figure 5 – Destroyed facility on 20 August 2011 with crater visible (red arrow). Debris is minimal and trees and fencing remain intact.

Causes of the building destruction are not readily apparent but are certainly conflict related. While several of the destroyed building and facilities visible in the 20 August image show clear signs of burning there is only one apparent crater visible. There is little, if any, scattered debris around the destroyed buildings and facilities that would be indicative of larger air dropped munitions. Proximate trees and fencing likewise remain intact (see Figure 5). Review of NATO Operational Media Updates¹ provided information on airstrikes in the area of Tawerga, indicating that NATO aircraft made attacks on four separate occasions. Specifically:

It is possible that relatively small air dropped munitions were used to destroy the sites in Tawerga, explaining the lack of scattered debris and nearby damage. However, in several of the cases it is likely that destruction occurred with great precision and no damage to the surrounding area, likely indicating the use of directly applied explosives or direct fire ground munitions rather than indirect fire or air dropped munitions.
